### MGBGTV8 – readjusting the overdrive inhibitor switch (and a surprising discovery)

In his previous V8NOTE681 Jim Livingstone suggested that the cause of his V8's overdrive cycling in and out of engagement was low oil level in the gearbox caused by a leaking output shaft seal. This conclusion appeared to be confirmed by subsequent testing on local roads. However, the cycling returned on the first long run with extended use of overdrive. On revisiting the problem last month he discovered that adjustment of the inhibitor switch has proved a more long lasting solution. He has recorded the procedure he adopted in this note.

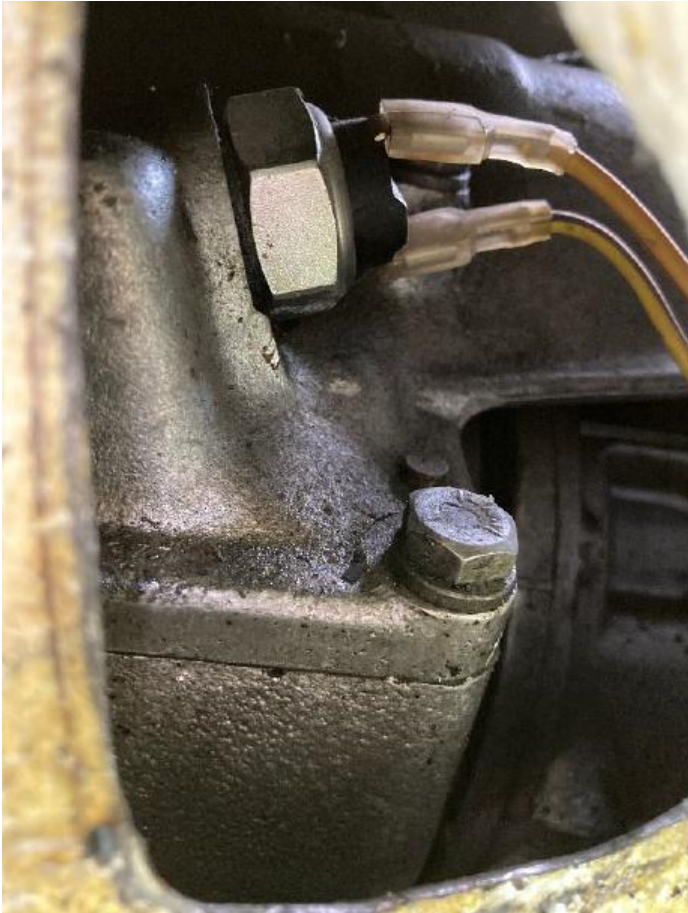
Figure 1 – inhibitor switch accessed by a rubber plug

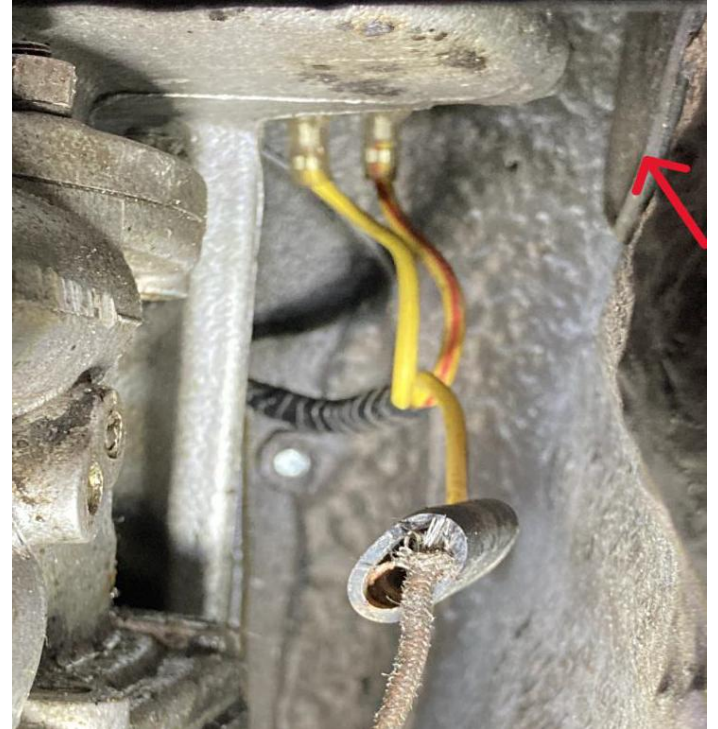
I had recollected seeing a rubber plug adjacent to the inhibitor switch (**Figure 2** arrowed) when I was under the

Figure 2 – inhibitor switch next to rubber plug (arrowed)

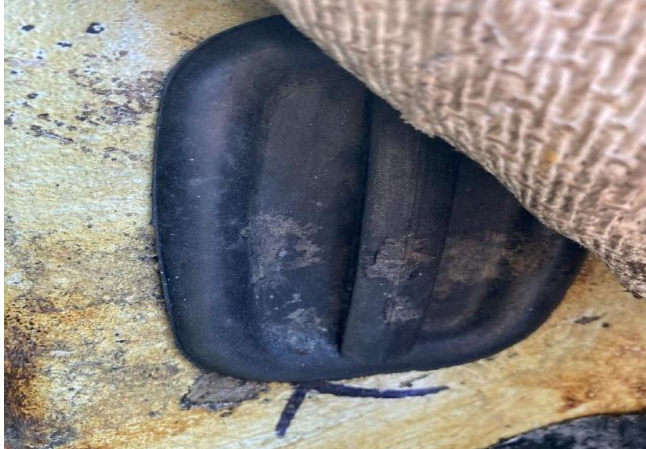
**Figure 3** – rubber blanking plug

1. Remove the rubber blanking plug from the passenger side of the transmission tunnel (**Figure 3**).

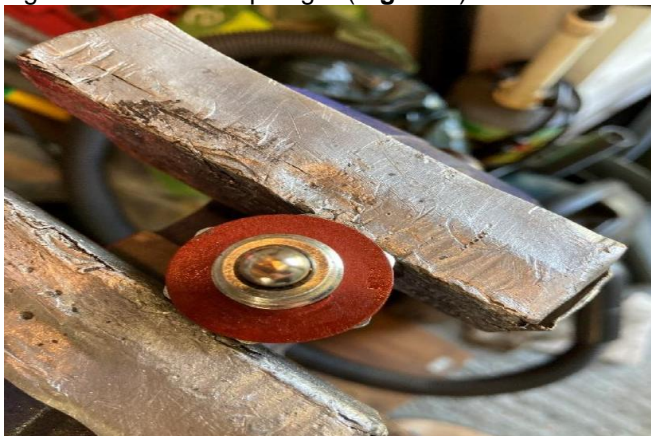
2. Remove the spade terminals from the inhibitor switch.
3. Loosen and remove the inhibitor switch using the 27mm spanners.
4. Visually examine the inhibitor switch. This one had signs of wear on the plunger (**Figure 4**).

**Figure 4** – inhibitor switch

8. Establish the thickness of spacer required to ensure overdrive engagement in 4th while inhibiting it in 3rd. I changed the thick original copper washer for a thinner fabric one.
9. Grease the switch plunger, reinsert and tighten.
10. Check the operation mechanically and electrically before reconnecting the spade terminals.
11. Refit all components removed on disassembly.
12. Test the operation of overdrive on the road.

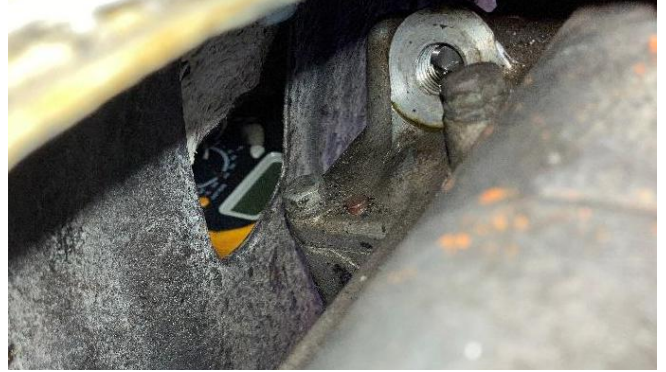
**Figure 5**

6. Examine the inhibitor pin in the gearbox and measure its depth from the flange in 3rd and 4th gear (**Figure 5**).

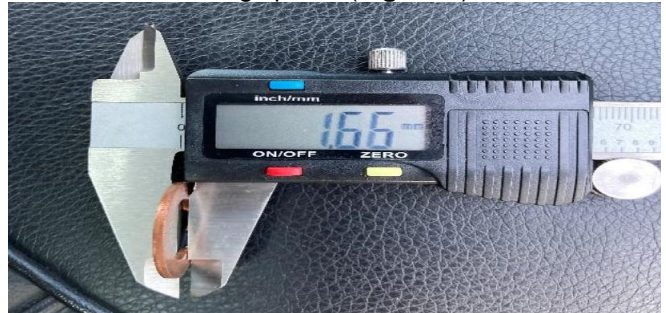
**Figure 6**

7. Measure the existing spacer (**Figure 6**).
