### MGBGV8 – renewing the fuel hose between the carburetors (and care points)

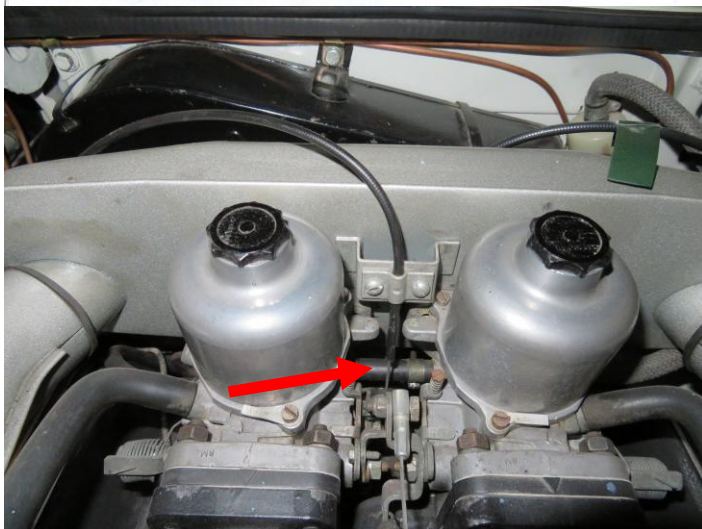
Figure 1 – leaking hose between the carburetors

Leakage from the fuel hose linking the carburetors on a V8 (see **Figure 1**) is a relatively common theme in the V8NOTES and the procedure for its replacement has been described several times and most succinctly in V8NOTE90 written by John Dupont. Here Jim Livingstone describes a couple of issues from his recent work on his carburetors and linkages. [V8NOTE90](#)

The initial leak in the interconnecting pipe between the carburettors was detected by the higher than usual frequency of pulsing of the fuel pump when the ignition was switched on. Tightening the hose clips only made matters worse and the leakage went from a drip to a stream of fuel and I quickly turned off the ignition.

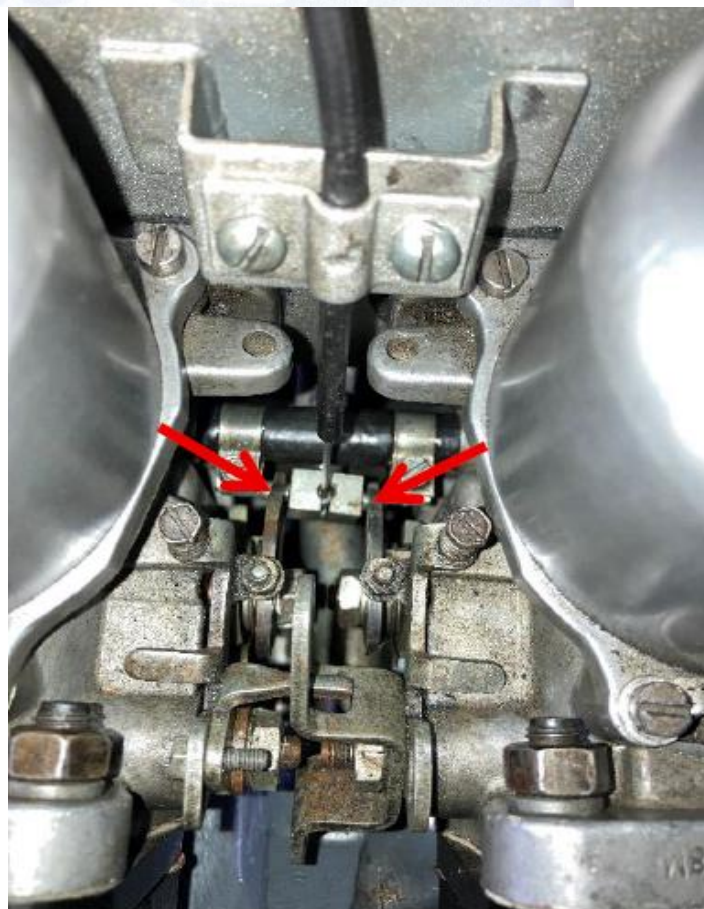
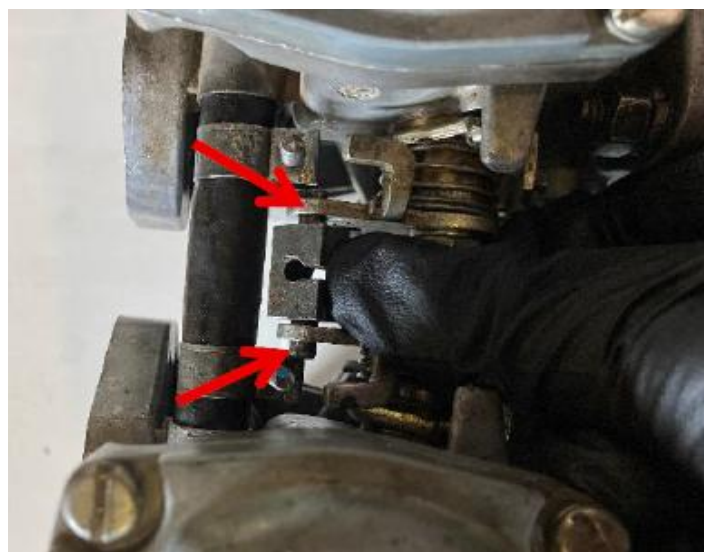
Figure 2 – foul between ears of the hose clip and choke trunnion (from above)

Figure 3 - foul between ears of the hose clip and choke trunnion (from below)

there is a definite "wrong way" as I was unfortunate enough to discover. As illustrated in **Figures 2 & 3** the ears of the hose clip must be oriented away from the choke trunnion, otherwise they will foul causing it to jam when raised and

the choke cable to disengage when lowered. In manufacturing this would be addressed by a foolproof feature in the design or at the very least visible guides and operator training – see **Footnote 1**. As the error is not discovered until the assembly is complete, the consequences are a full disassembly.

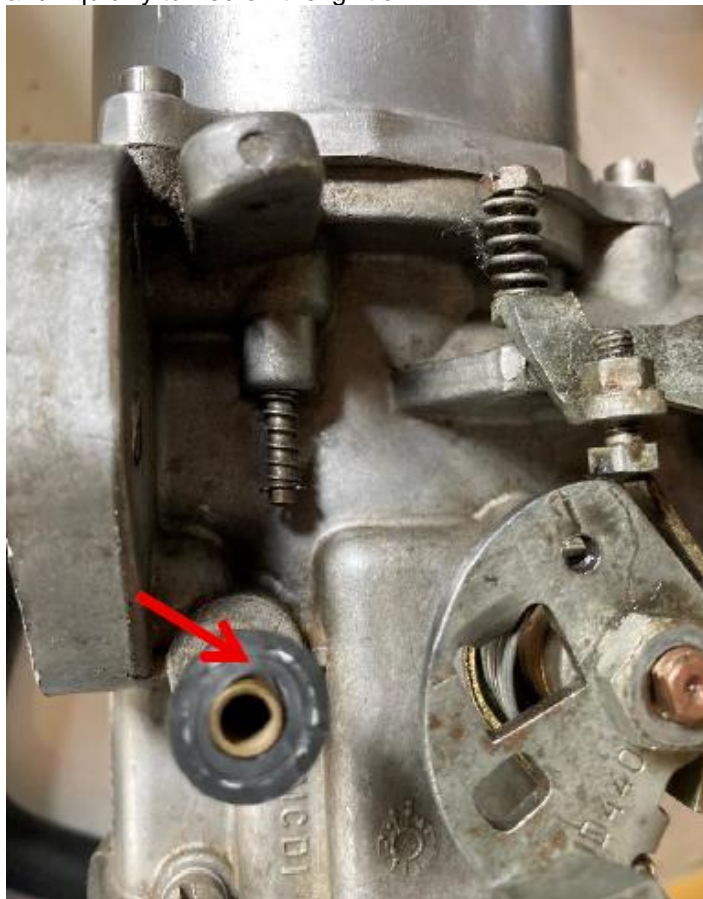
**Figure 4** - ovality remained with a clear gap between hose and pipe

I had purchased two metres of Gates Barricade ¼" fuel hose (GFH1025X) in anticipation of future requirements to replace perished hose. Having recently used a section of this to replace the hose in question I was surprised that it was already leaking. On examination the existing hose appeared in good condition without signs of hardening or perishing from exposure to E10 fuel. However, the **bore was noticeably oval** on both the removed part and the coil of 'new' hose. I cut off a narrow section of this and slid it over the fuel feed pipe of the left carburettor in expectation that the ovality would disappear when assembled.

However, as illustrated in **Figure 4** the **ovality remained** with a clear gap between hose and pipe evident.

I next measured the outside diameter of the pipe which came to 0.235" which probably explains its inability to remove ovality from a nominal ¼" (0.250") bore hose. Anxious to return the car to a roadworthy condition and unwilling to risk more oval hose I turned to a short section of braided hose (GGT101) I had purchased last Autumn. At 2½" this was over long for this application but was easily shortened with the aid of a rotary hand tool and cutting disc.

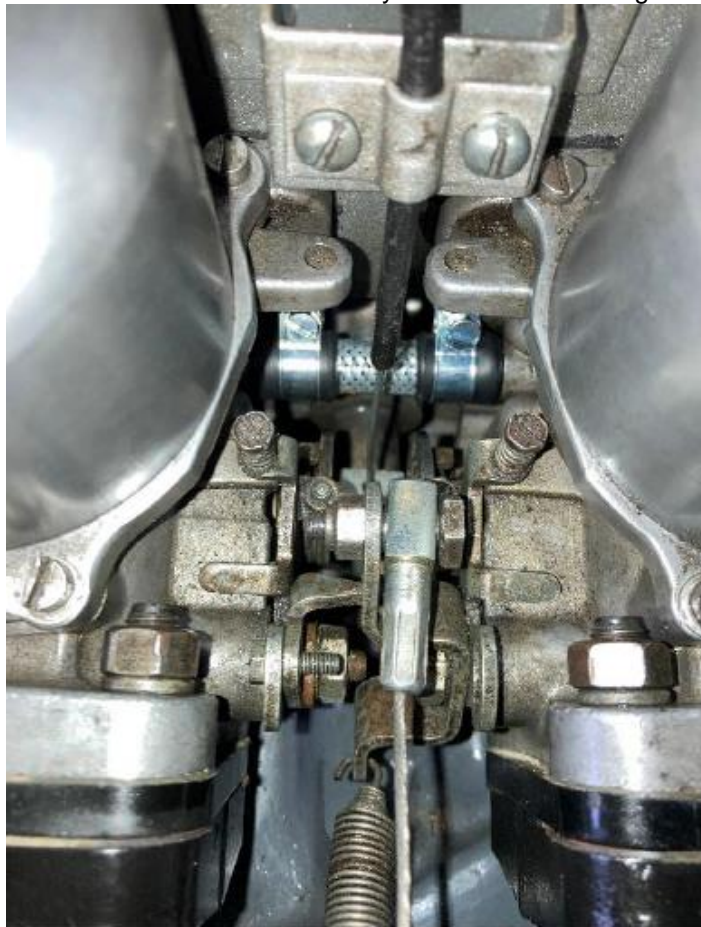
**Figure 5** – completed installation with new braided hose and correctly oriented clips

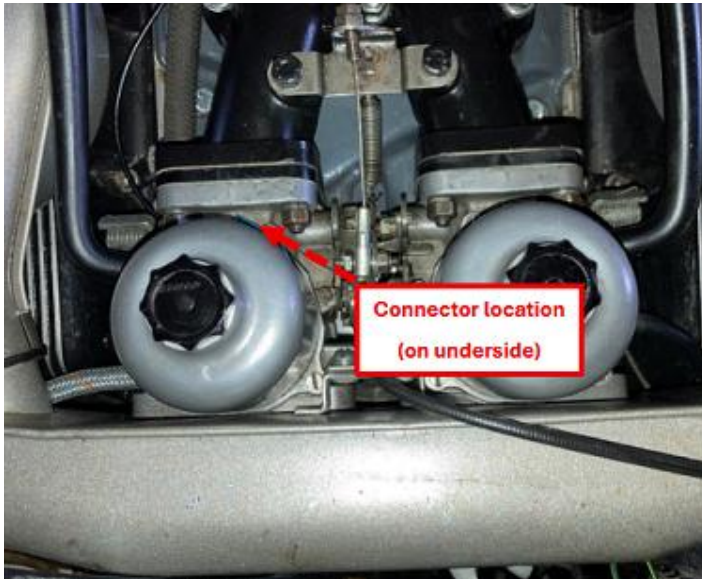
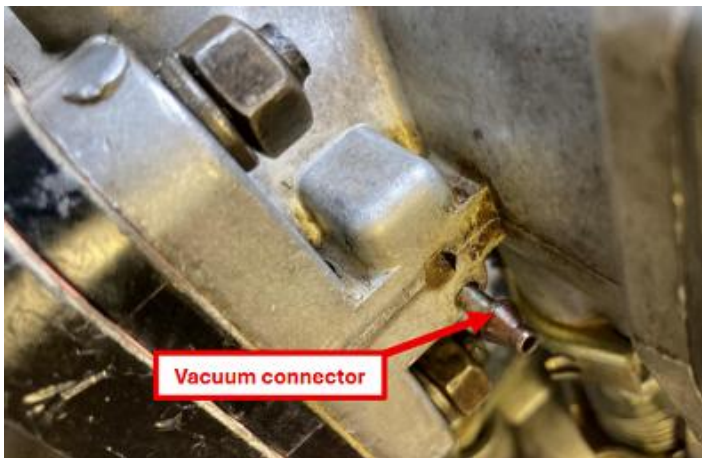
The vacuum tube connector is located on the underside of the left carburettor and tube connection is made via a small bore rubber elbow.

As mentioned in V8NOTE90 there are other opportunities for errors when reassembling. The first is failing to ensure that the choke trunnion is engaged in the choke operating levers (fast idle cams) of both carburettors. The second is the vacuum advance tube which should be fitted to the connection on the underside of the left carburettor before the Adaptor is lowered on to the Induction Manifold – see **Footnote 2**.
