2004 MG ZT-T 260 (vin 206)

Are you dicing with death?

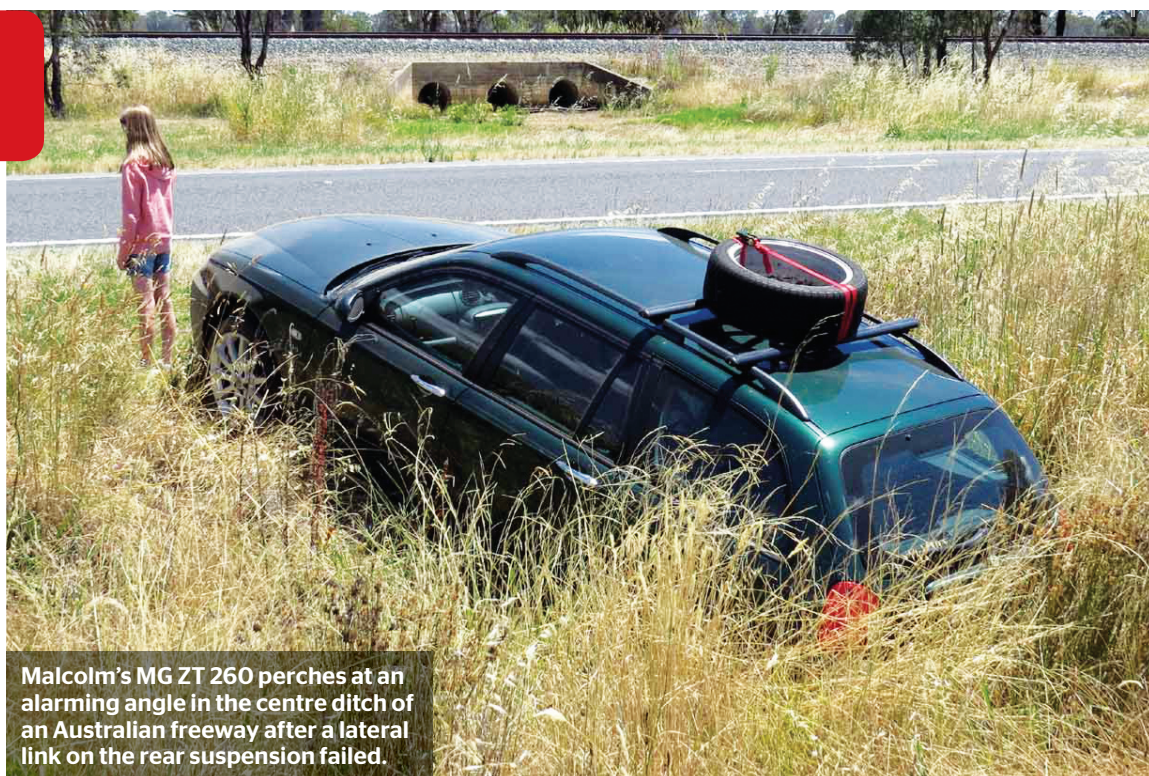
Malcolm's MG ZT 260 perches at an alarming angle in the centre ditch of an Australian freeway after a lateral link on the rear suspension failed.

I now know that these failures can be deadly - just after the story was published, I had one fail at high speed on the freeway from Melbourne to Sydney. I was doing 120km/h on a straight stretch when I felt and heard a bang. The car immediately started to weave about, the swerving getting

more violent as the errant rear wheel flailed about until I was unable to keep the car straight while attempting to brake. I lost control and the car spun around and careered off the road backwards into the centre ditch, narrowly missing two concrete culverts. Scary stuff...

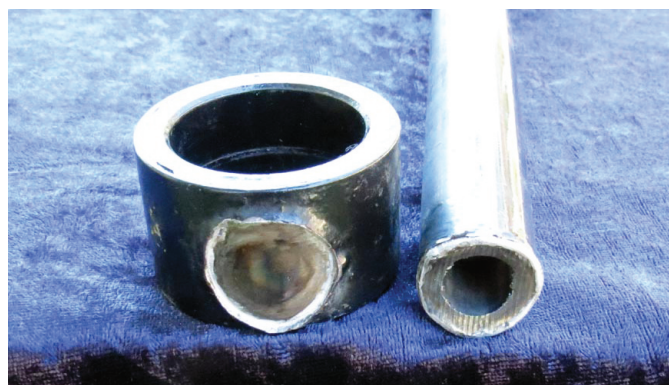
If you look closely at the broken link you can see that the original welding was minimal. When I went to pick

up my re-welded lateral links from Dave, his first reassuring comment was that these will never break again. More importantly for other Two Sixty owners though, his second comment was more cautionary - he would not take his family in any car that still had the original links on them. He was at a loss to explain how any engineer could have let the original parts be fitted to the cars, saying: 'The welding on my letterbox is stronger than these!' I muttered something about the death throes of MG Rover in 2004, but Dave was unimpressed, saying that someone could be killed.

Weld penetration and metal added by the welding were both minimal on the original lateral links fitted to Malcolm's 260.

His (and my) advice to all Two Sixty and Rover 75 V8 owners is, for the small amount of time and investment needed, take the four links off now and get someone you

trust to run a decent weld around the joints, or have new ones properly made. You will sleep more easily at night and drive with some peace of mind. An added benefit of doing this is that many owners will find that the toe-in and camber adjusting bolts at the eye ends of the links are seized solid thanks to the aggressively corrosive winter road treatments in the UK. They will have to cut the links free and source new bolts and bushes along the lines I mentioned in my report on old 206 in June last year. So, in addition to peace of mind as Two Sixty owners tear along the motorways, they will be able to have an effective four wheel alignment done and save on rear tyres - which on a 260, as we all well know, don't last very long anyway...

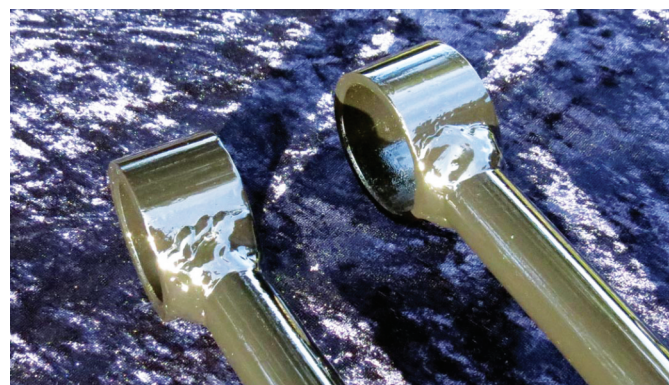
Externally, the new welding looks significantly stronger. Dave assures Malcolm that it really is stronger, too!
