MGBGTV8 restoration project from David Smith – Report 2

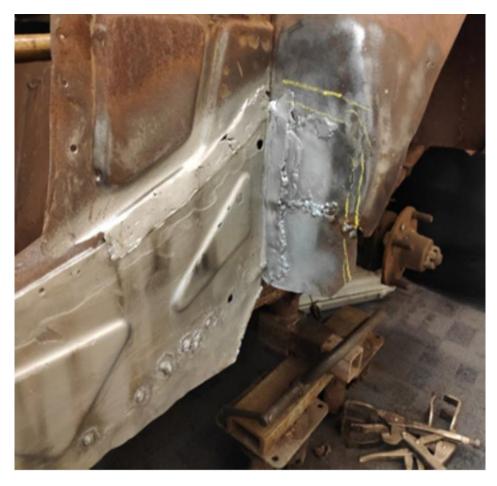
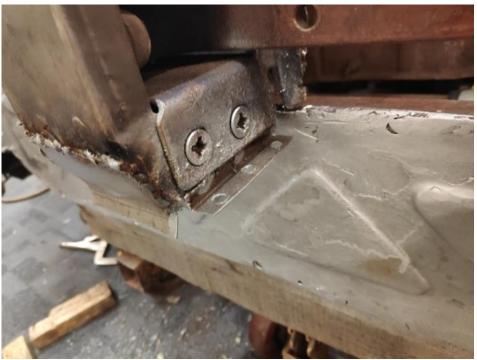
The chap that had started the repairs had done a good job but one thing that didn't seem right was the sill to door alignment; gap was tapered and just too tight. The castle, inner etc. had all been replaced but as this was going to be a nut and bolt resto it had to be right now, so the new sill had to come off. I also wanted to see what sort of protection was on the insides.

The back end to the sill was a bit tatty so it gave me a chance to tidy it up, even though it will be hidden behind the outer sill. The protection he had done was great; however I gave it all another coat of epoxy sealer and then some weld thru zinc primer on the welding faces, as a token gesture

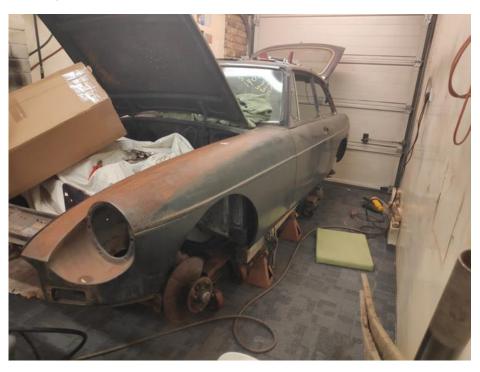
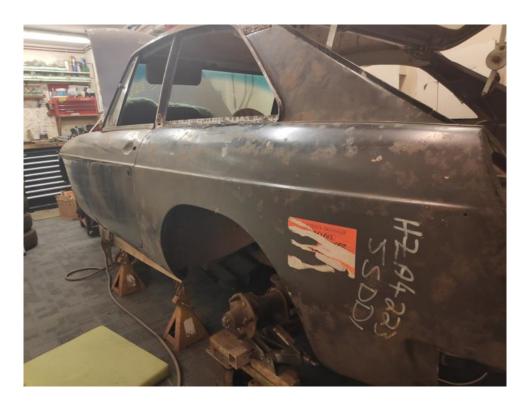
Body swage aligns quite well and is fairly straight. What doesn't seem any better though from the BMH panels I used to use years ago and now is the fit and curvature around the wing to sill areas both front and back, and the general curvature of wing to door, however all manageable later on.

And so on with the front wing, bit of fiddling and adjustment and the wing is on and bolted up tight for now.

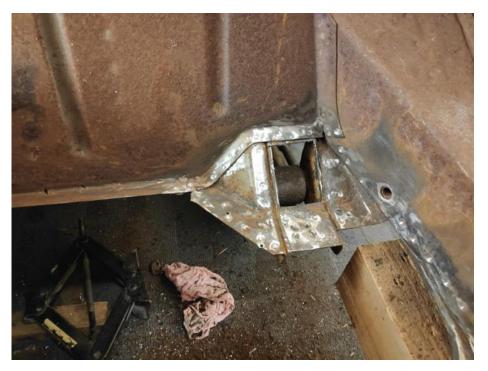
The rear heelboard extension piece was rusty and cut out. Again a where not being welded a coat of epoxy sealer and then on the weld thru edges a coat or zinc weld primer. Also a small section of the spring hanger needed replacing, hadn't rusted thru yet but now it was easier now than later on. Got carried away with the hole punch here but this was almost the same amount that the OE piece had in it, just means a load of grinding coming up.
