Replacement RV8 radiator cover

The plastic radiator cover often breaks at the offside mounting point. Here Peter Garton describes his experience with the problem and how he fitted an upgraded replacement.

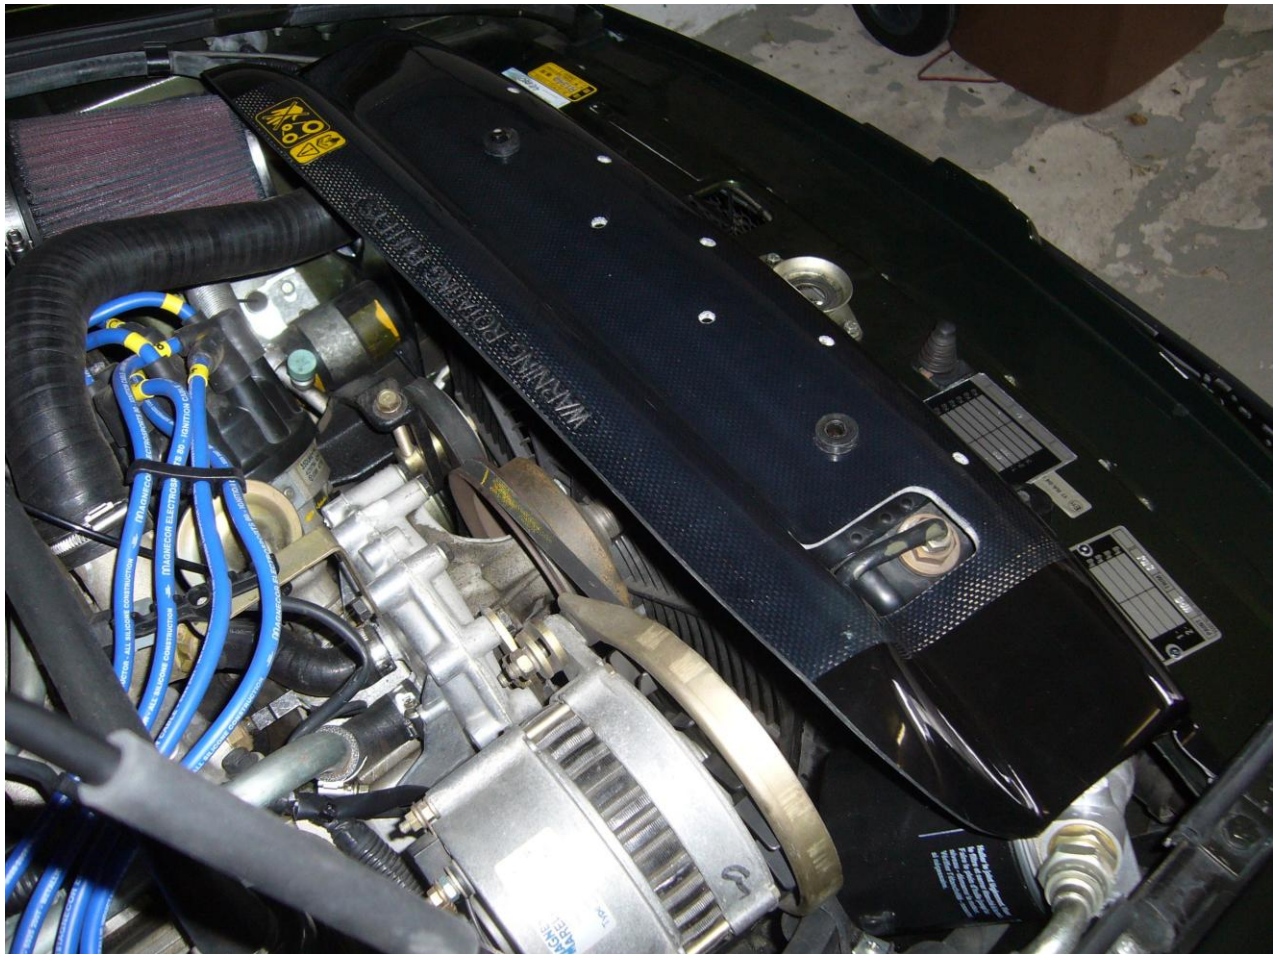
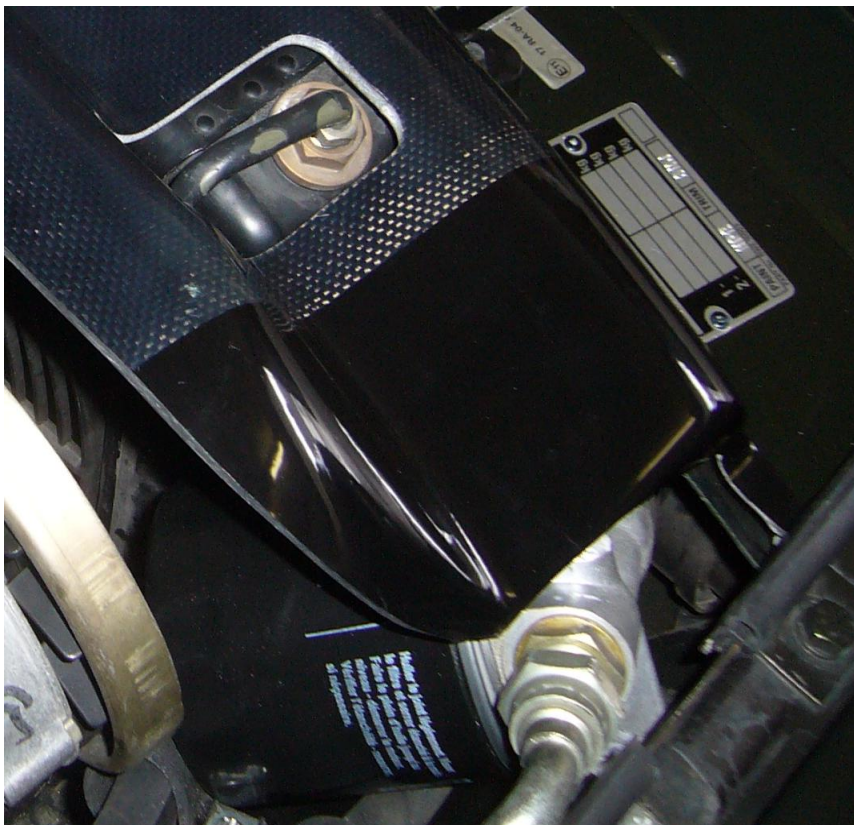
The original RV8 radiator blanking panel is, in fact, quite fragile and tends to fracture around the mounting bolts at the top. This is easily caused, for example, by leaning on the cover when working in the engine bay. In my case I discovered a hairline crack at the top left hand mounting bolt (on the offside) and decided to improve the cover by using the alternative superior one supplied by Clive Wheatley, which is a sort of glass fibre composite. As one can see from the photos, the offside edge has had to be trimmed because of the oil filter unit which has been mounted further forwards by the MGOC Workshops when they installed the EPAS system on my RV8.
