Solving the second gear problem with an LT77 or R380

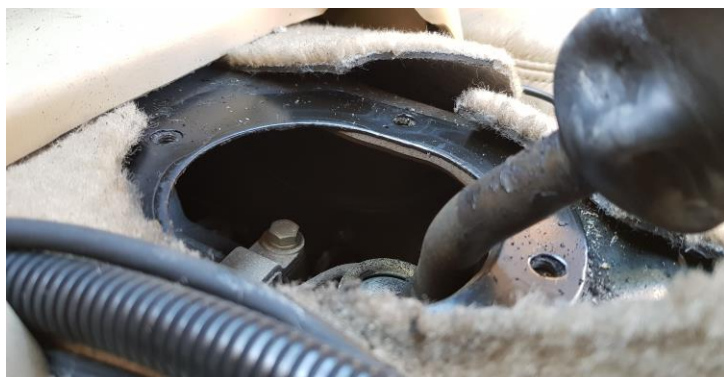
RV8 – contact between the gear lever and the edge of the opening

So I removed my rubber dust excluder and found that when second gear is selected there is about a 1 to 2 mm gap between the lever and the opening of gear lever hole in the transmission tunnel and with fourth gear selected it was actually touching the edge of the hole. Stuart thought with such a tight clearance the rubber dust excluder could get between the gear lever and the edge of the hole.

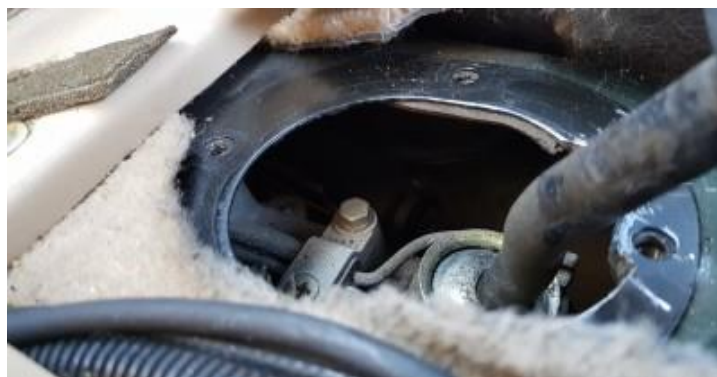
RV8 - second gear with the cut out made

I set about relieving the clearance in the second and fourth gear position on the transmission tunnel. I marked out the tunnel then stuffed a rag around the gear lever mechanism and carefully cut out the area of the hole with a jigsaw. Once this was done I filed the edges removed the rag and any metal swarf that the rag didn't catch was picked up with a magnetic screwdriver. I took the car for a drive there was no crunching or popping out of 2nd gear.

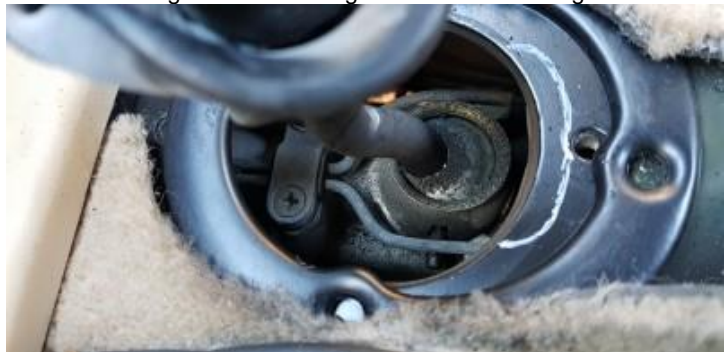
RV8 - cut out marked

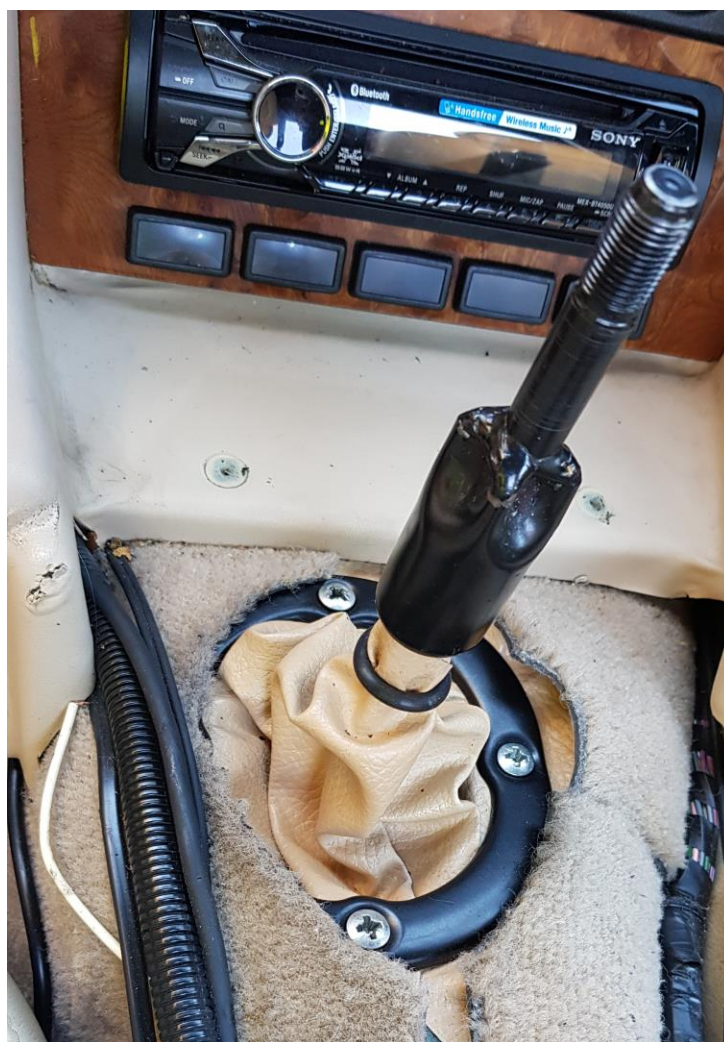
Similar situation with an MGBGT V8 conversion

Mike Howlett mentioned that "when I put the R380 gearbox in my MGBGT V8 conversion I had the same issue. I cut a semi-circular piece out of the tunnel top behind the lever aperture and fabricated a cover plate held with screws. This plate allowed more rearward movement for the lever. It works like a charm."
