RV8 heater rail modification to avoid a heavy indentation on a rubber heater hose

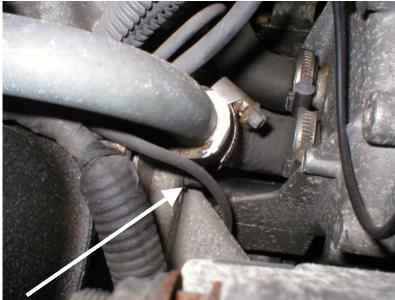
Heater rail pipe showing the alternator bolt that can get pushed into the rubber hose below – it's just in view bottom left of photo above

Steve Newton has come across a number of RV8s with an indentation on an elbow shaped rubber heater hose on the end of the heater rail near the alternator. The heavy indentation is made by a bolt head on the alternator cradle pressing against the rubber tubing. Steve says it's not seen on every car so why does it appear on some RV8s?

the manufacture of the heater rails there was some variability in the positioning of the welded brackets on the rail so when the heater rail is bolted down with the fixing bolts, the end of the rail near the alternator is too close to the alternator. So the elbow is pressed up hard against the bolt head on the alternator. The cure is not to bolt up rail to the fixing

It seems that in

point

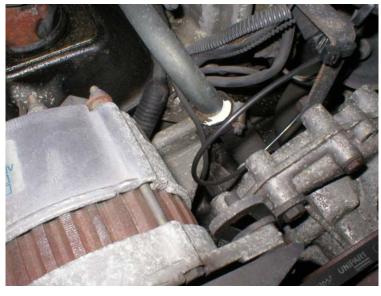
Above: showing the front cover to heater rail hose in place. The heater rail runs along the top of the engine back to the heater and is fixed by a bracket across the engine

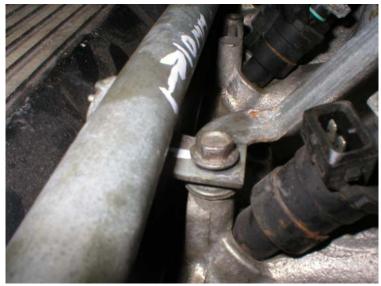
Above: showing one of the two fixing bolts that hold the heater rail pipe in place, these can be removed to allow the heater rail to be moved forward but must be put back to hold the fuel rail in place.
