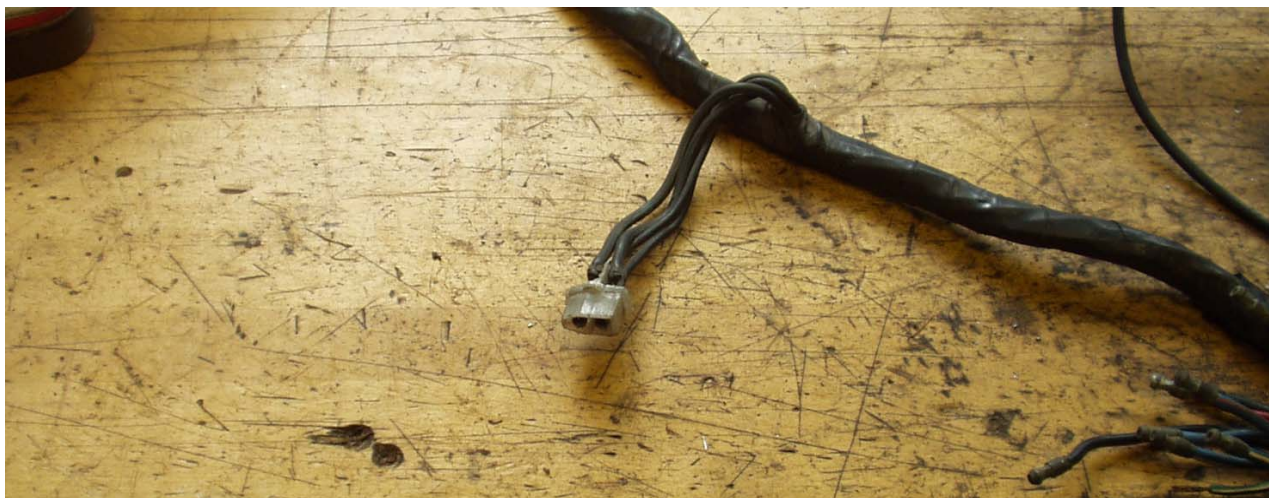
The wiring loom of my MGBGTV8 was not in bad condition, but they always have a few small problems. This one had a broken connector to one of the cooling fans - see photo above (Wiring 3).

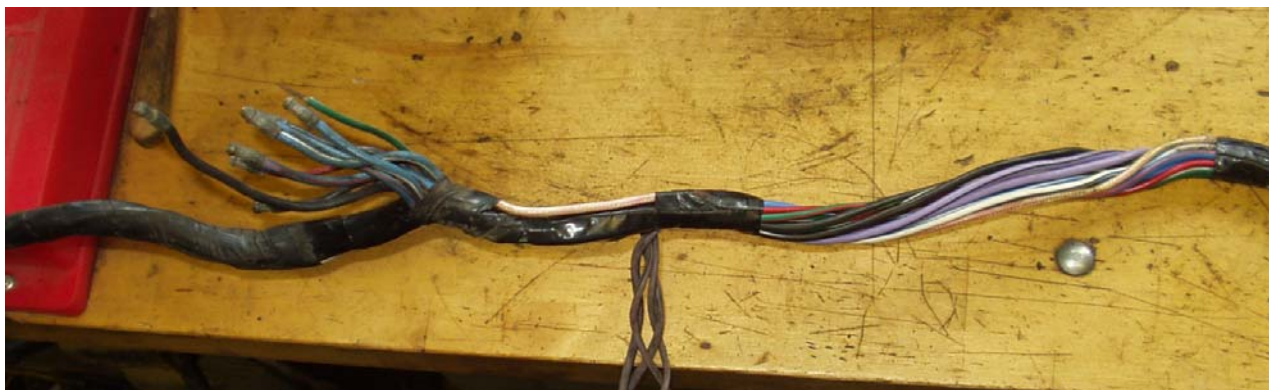
When I removed the outer layer of loom tape, I found evidence within the loom that some extra wires were added by the Factory. Presumably they modified the 1800 loom. For example, the pink resistive ballast wire that powers the coil was found to be taped to the loom and then covered with a second layer of black loom tape - see photo above (Wiring 2). This pink wire will be removed from the loom and replaced with a plain white wire, because I always fit a Pertronix electronic unit inside the distributor, and it requires an un-ballasted 12-volt supply.
