## Repairing an overdrive switch fault

Barrie Jones had been experiencing problems with the overdrive switch on his MGBGT V8, Glacier White 0672. Operating the wipers or the screenwash sometimes caused the overdrive to disengage momentarily, no matter how careful he was. This note describes how he cured the fault. (Nov 09)

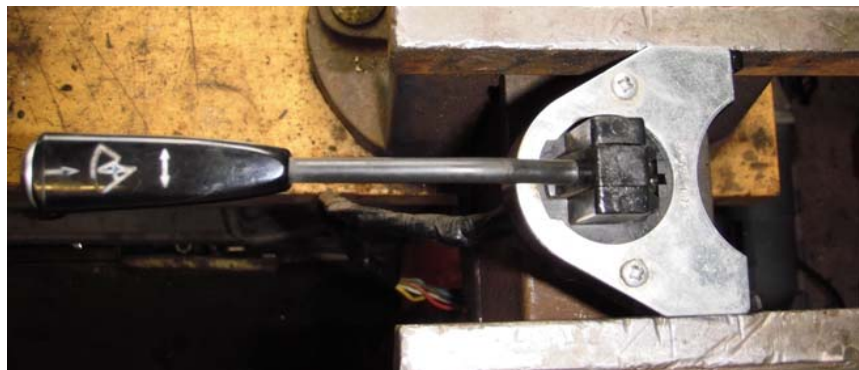
Photo 1: stalk switch mounted in a large vice for inspection.

I therefore removed the switch from the steering column and mounted it in a large vice (**photo 1**). If you look at the metal cover, you will see a part number and a date code. Mine was stamped 1873, so it was manufactured in week 18 of 1973. That ties in with the build date of the car so it is probably original. (Looking at the copy of the Factory production control records made by the late Geoff Allen, the Date Advised for Delivery for Barrie's V8 was 25<sup>th</sup> September 1973.).

Before dismantling, I tested the connection between the white terminal and the yellow terminal. A digital ohm-meter was used and this confirmed that the switch was prone to disconnecting whenever the stalk was operated in order to simulate use of the wipers.

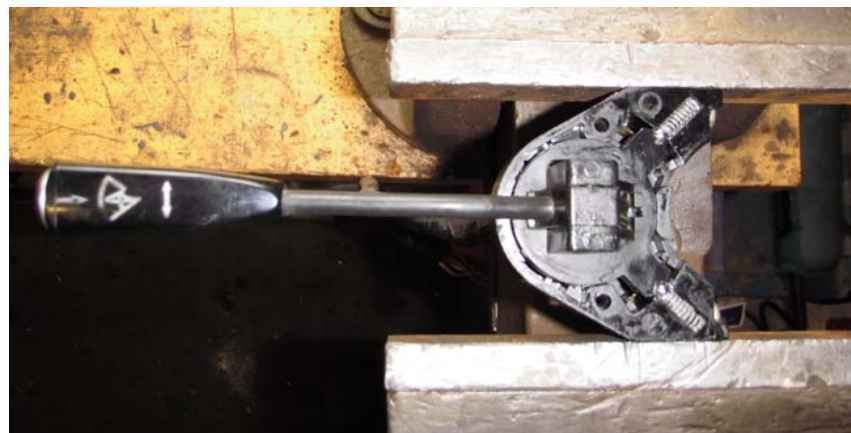
The next step was to take the switch apart. Remove the two screws and carefully lift the metal cover off. This will reveal two locating springs and ball bearings (**photo 2**). These must be removed with care, or else they will jump out.

Photo 2: switch with the metal cover removed.

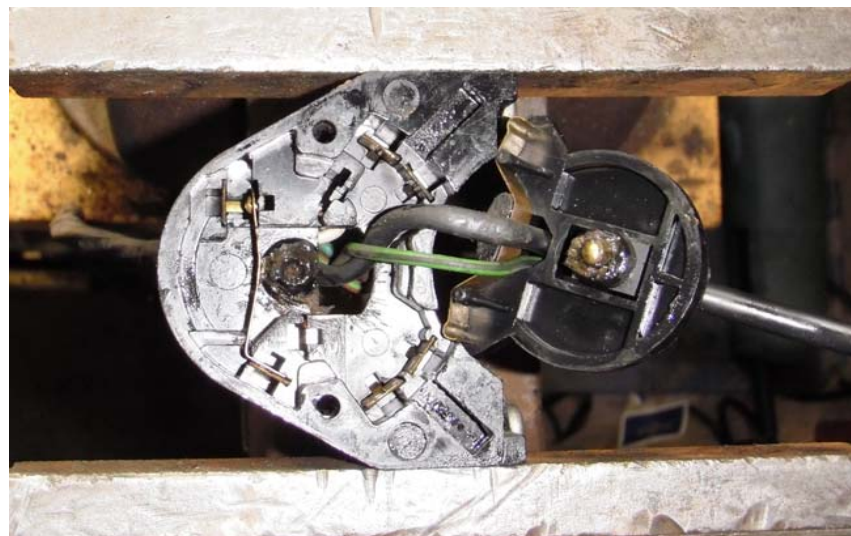
Photo 3: modified switch.

Next, gently ease the switch apart, so that you have access to the internals. The long, straight connector to the left can be extracted upwards. The contact on the end can then be cleaned, and I decided to give the metal a double kink in the

centre, in order to bias it towards the engaged position. The modified switch can be seen in **photo 3**.

After lubricating the springs and balls with a little silicone grease, the switch was re-assembled and tested. It felt much more positive, and my meter showed that the overdrive switch was more reluctant to disengage accidentally.
