Gearbox trouble with the Factory MGBGT V8 box

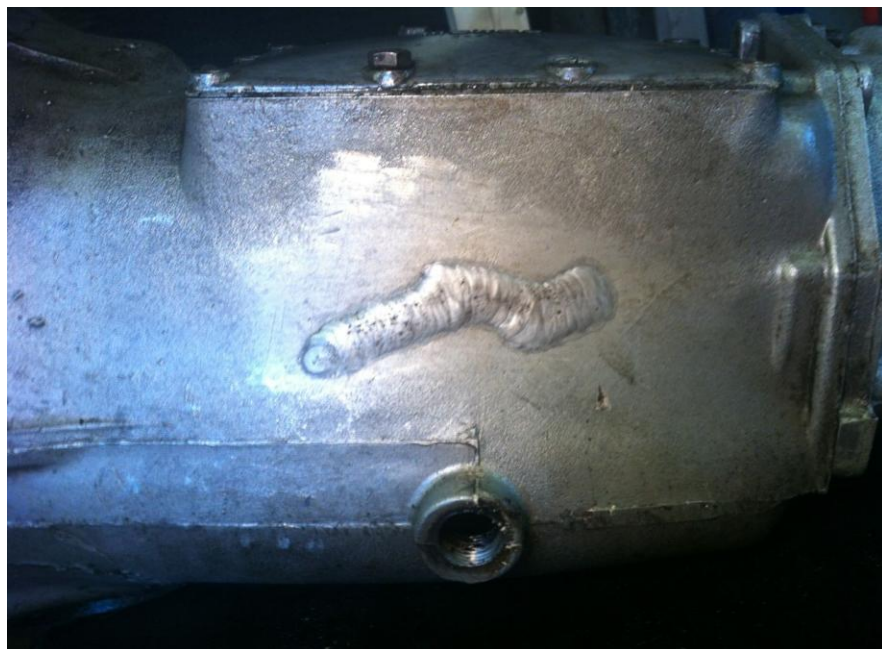
External view of the welded crack in the gearbox casing

Nick Gray responded saying “I have a gearbox casing that has been welded in what sounds like the same position. I understand this is a common crack caused by shock loading the reverse gear (putting the car in reverse before it has lost all forward momentum) causing the reverse gear shaft support to fracture at the base. I bought the gearbox for breaking which needed a lay shaft, but understand from the previous owner it been working well. The downside is that unless the welded repair is spot on you suffer a noisy reverse gear due to slight shaft misalignment. So yes, welding is possible but it is a tricky job to get exactly right - notwithstanding that welding castings is tricky in itself as thermal stresses can crack the weld as it cools.”

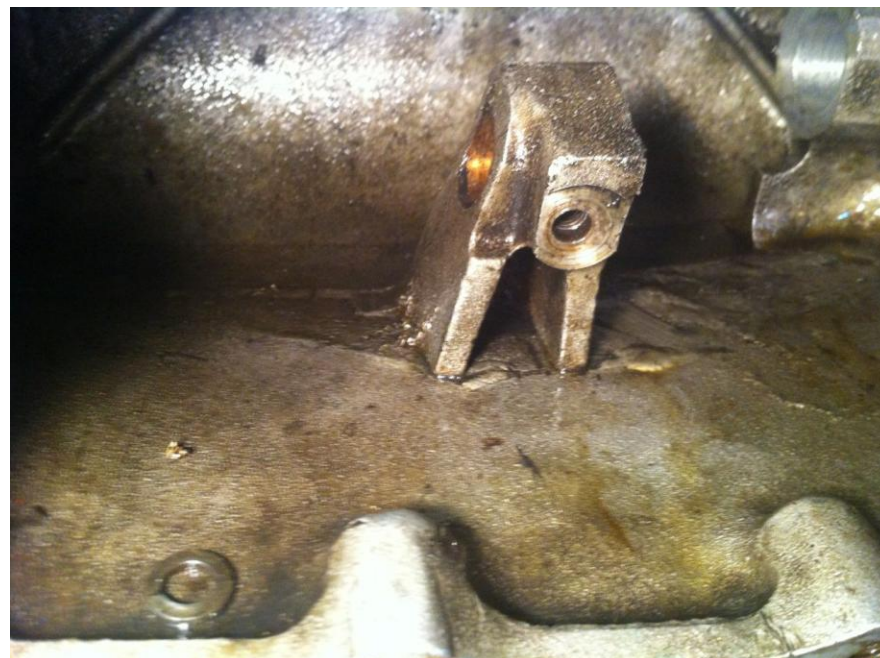
Internal view of the casing - the repair to the reverse shaft bracket is clearly visible as are weld fillets on the left hand side reattaching the bracket to the casing

I have also taken a few photos showing the **interior of the gearbox** and you can see the rather messy weld on the left hand side of the support where the bracket has been reattached to the case. You can also make out a bit of the weld repairing the crack in the casing the reverse gear support caused when it broke. I think this was a fairly poor repair - the bracket is a few degrees off the perpendicular to the case and reverse shaft that ran through it which probably explains why the chap

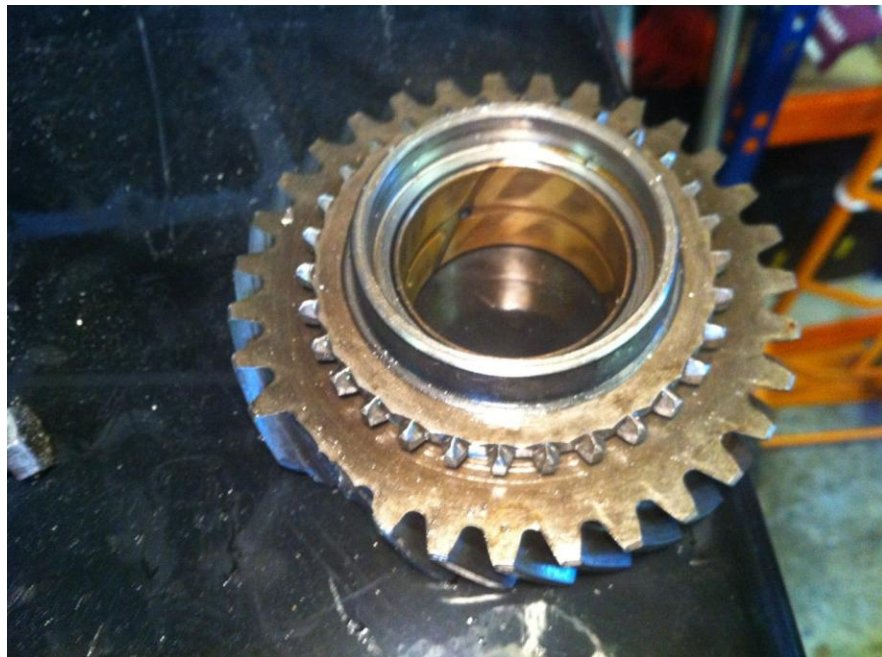
A few teeth missing from first gear - the probable result of V8 torque and too many wheels spins from stationary

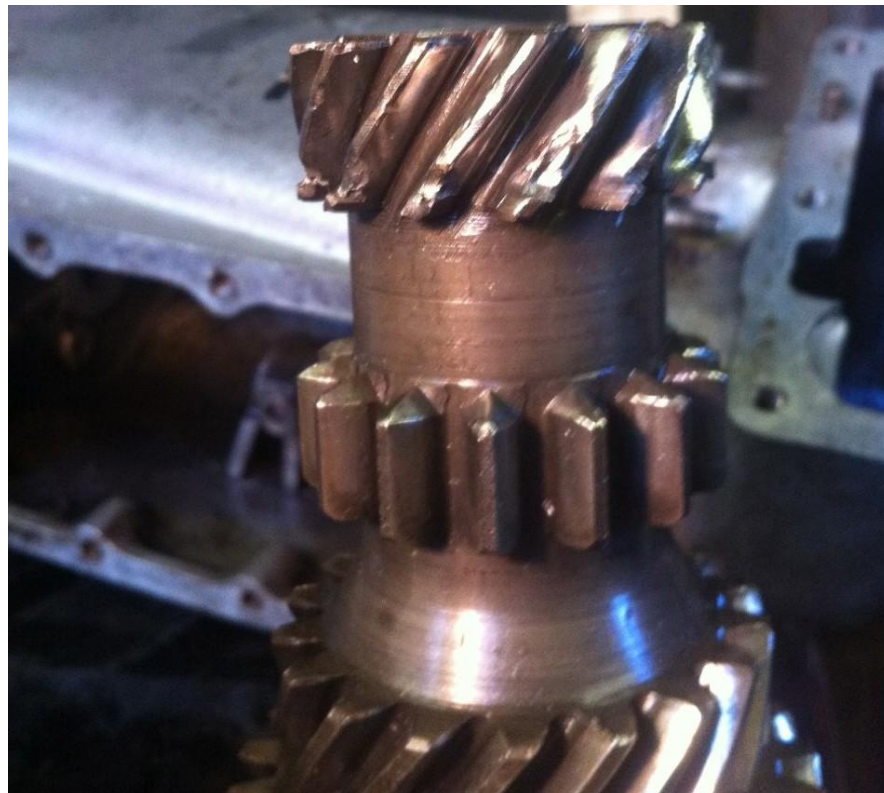
Inevitably the lay shaft in the second gearbox had also been damaged beyond repair - a pity as these are becoming next to impossible to replace
