MGV8 - renewing the oil seal in the overdrive output shaft

Jim Livingstone had some overdrive issues recently and traced them to a low oil level in the gearbox caused by a leakage. The procedure to change the various seals is relatively straightforward but he found the information available in the official Manuals is sparse to non-existent. He thought fellow V8 owners might appreciate the information he gathered from his research into the subject.

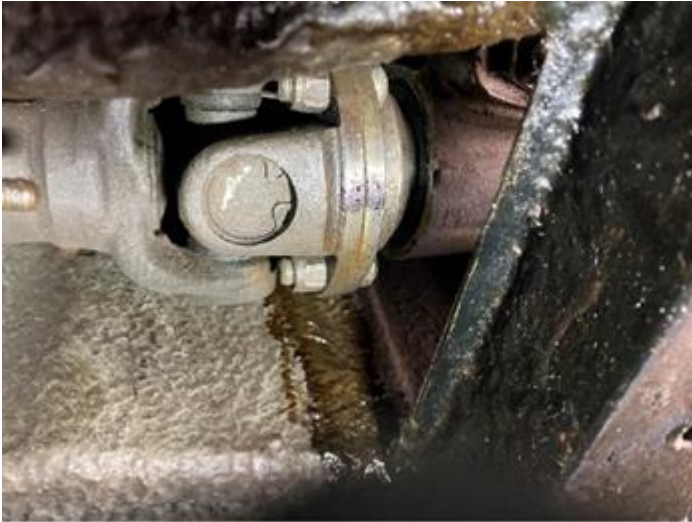
Figure 2 - Paint alignment marks on the gearbox and propshaft flanges to ensure reassembly in their original position

1. Drain the Gearbox.
2. Block one rear wheel and jack up the other to allow rotation of the propshaft.
3. Paint alignment marks on the gearbox and propshaft flanges to ensure reassembly in their original position (Figure 2).

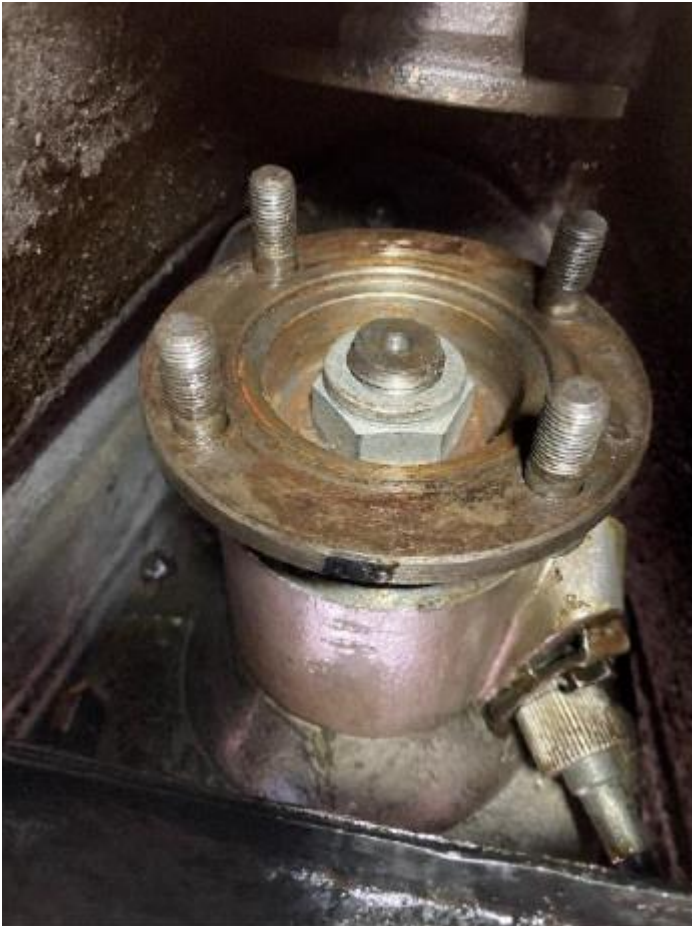
Figure 3 - Mark the relative position of nut and shaft with a centre punch to aid reassembly

5. Mark the relative position of nut and shaft with a centre punch to aid reassembly (**Figure 3**). No torque figure is specified for this nut in the Data section in the Workshop Manual.
6. Attach the restraining tool to the gearbox flange using two of the original bolts, spacers/washers and free running 3/8" UNF nuts (**Figure 4**). The flange bolts have D shaped heads and are partially captive in the flange. Those not required to secure the restraining tool can be removed via a machined recess at approximately 10 o'clock in the rear of the overdrive casing.

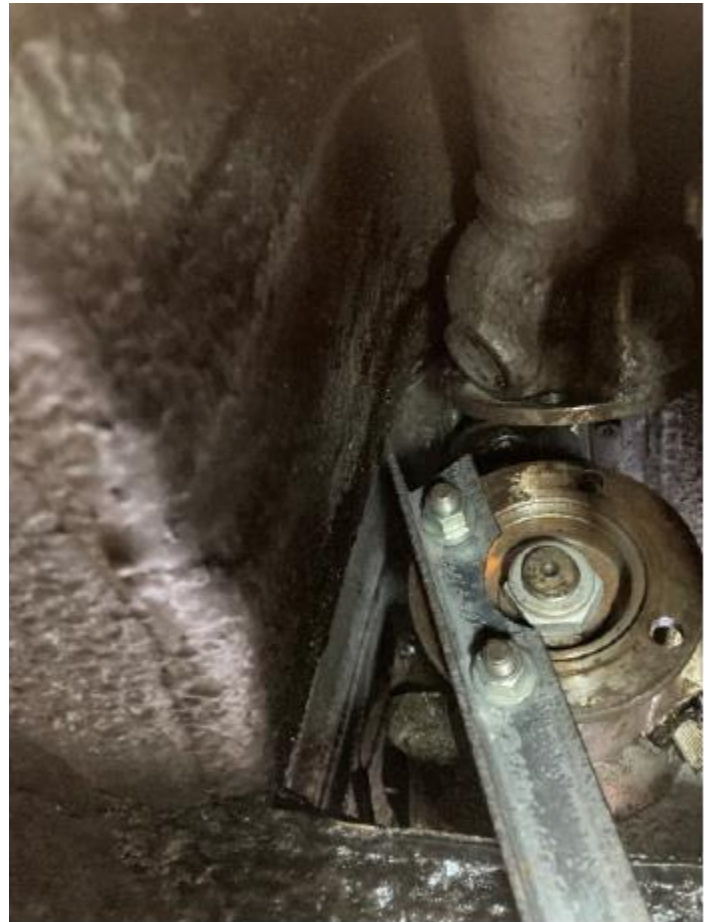
Figure 4 - Attach the restraining tool to the gearbox flange using two of the original bolts, spacers/washers and free running 3/8" UNF nuts

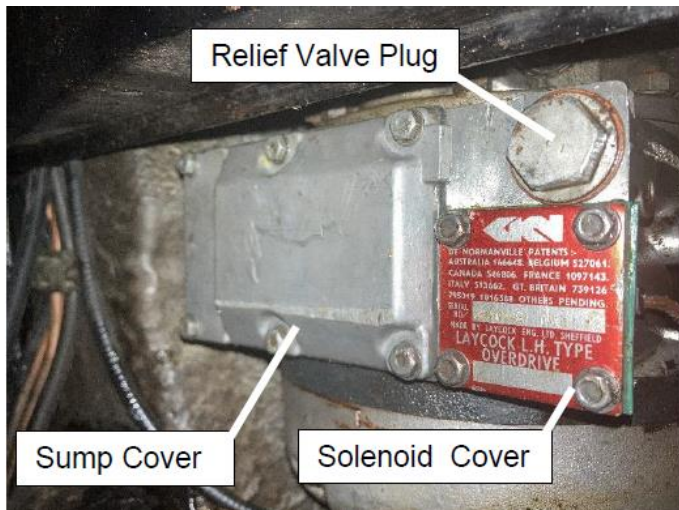
Figure 5

1. Remove the sump cover and filter screen (6 x 3/16" screws). If sticking there is a jacking point adjacent to the relief valve plug (Figure 5).
2. Wash the sump and magnets thoroughly in brake cleaner.

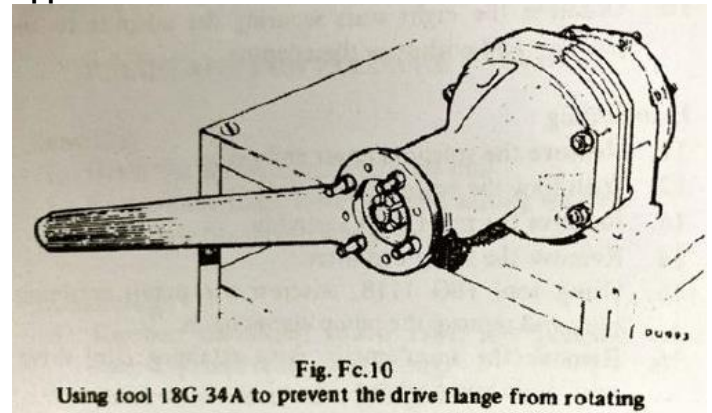
Restraining tool for drive flange

- Fabricate from a 500mm length of 30mm x 30 mm x 3mm angle or similar.
