MGBGTV8 rebuild report from Lorraine Noble-Thompson

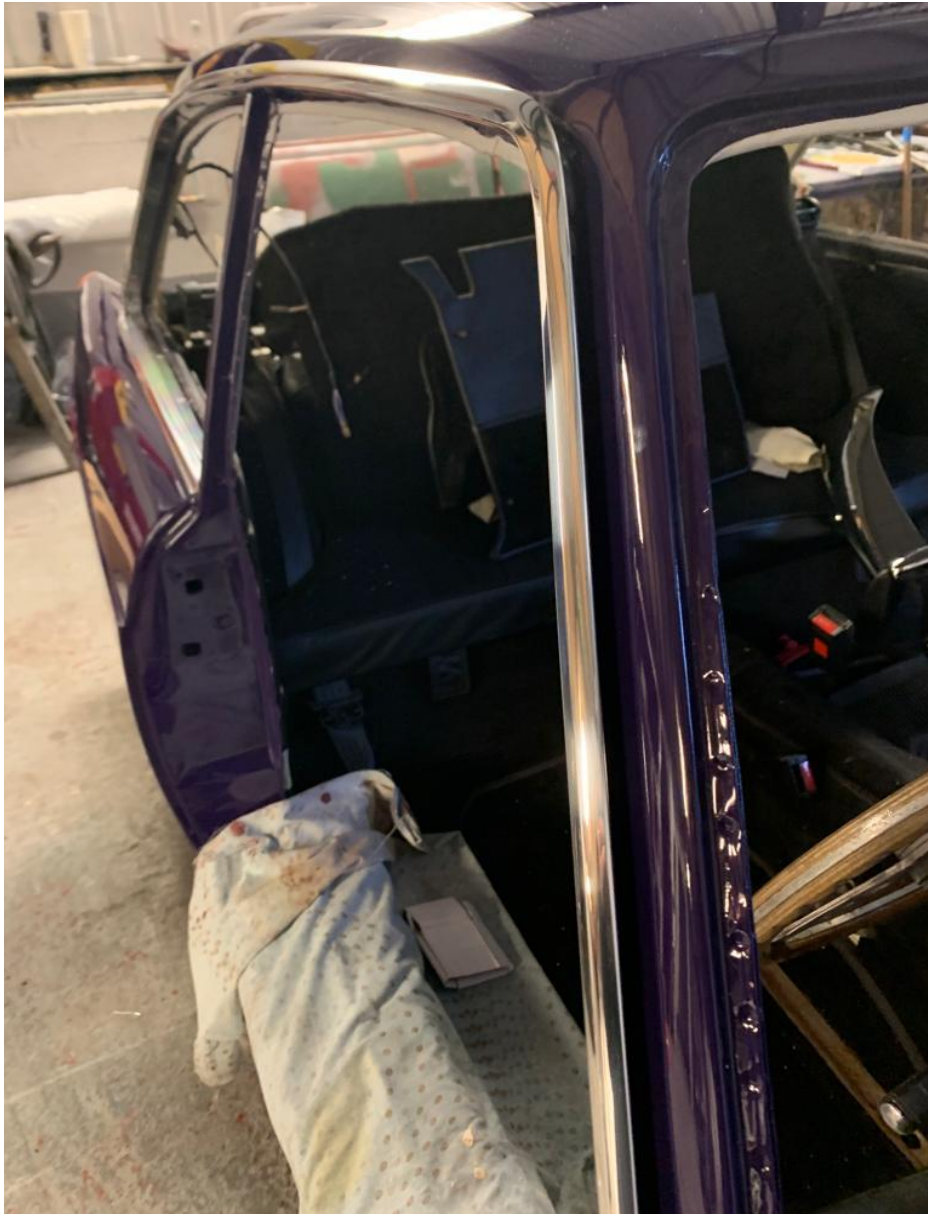
Geoff Allen (who was in Rectifications for 27 years) said fitting the headlining was a difficult task but it now in place. Windscreen & tailgate soon to go in.

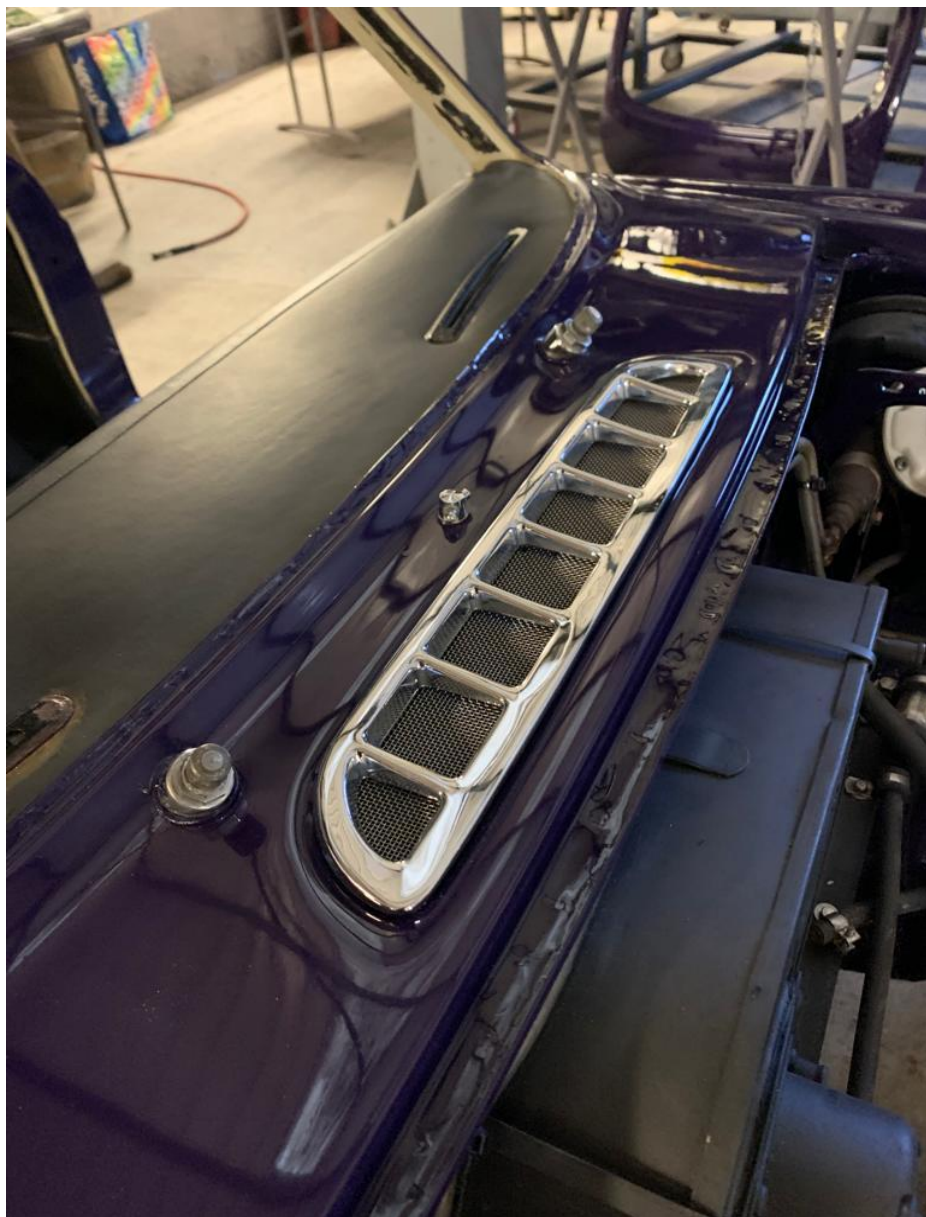
Air intake in front of the windscreen with an aftermarket mesh which keeps leaves out so they don't collect at the bottom of the air chamber with road dust.

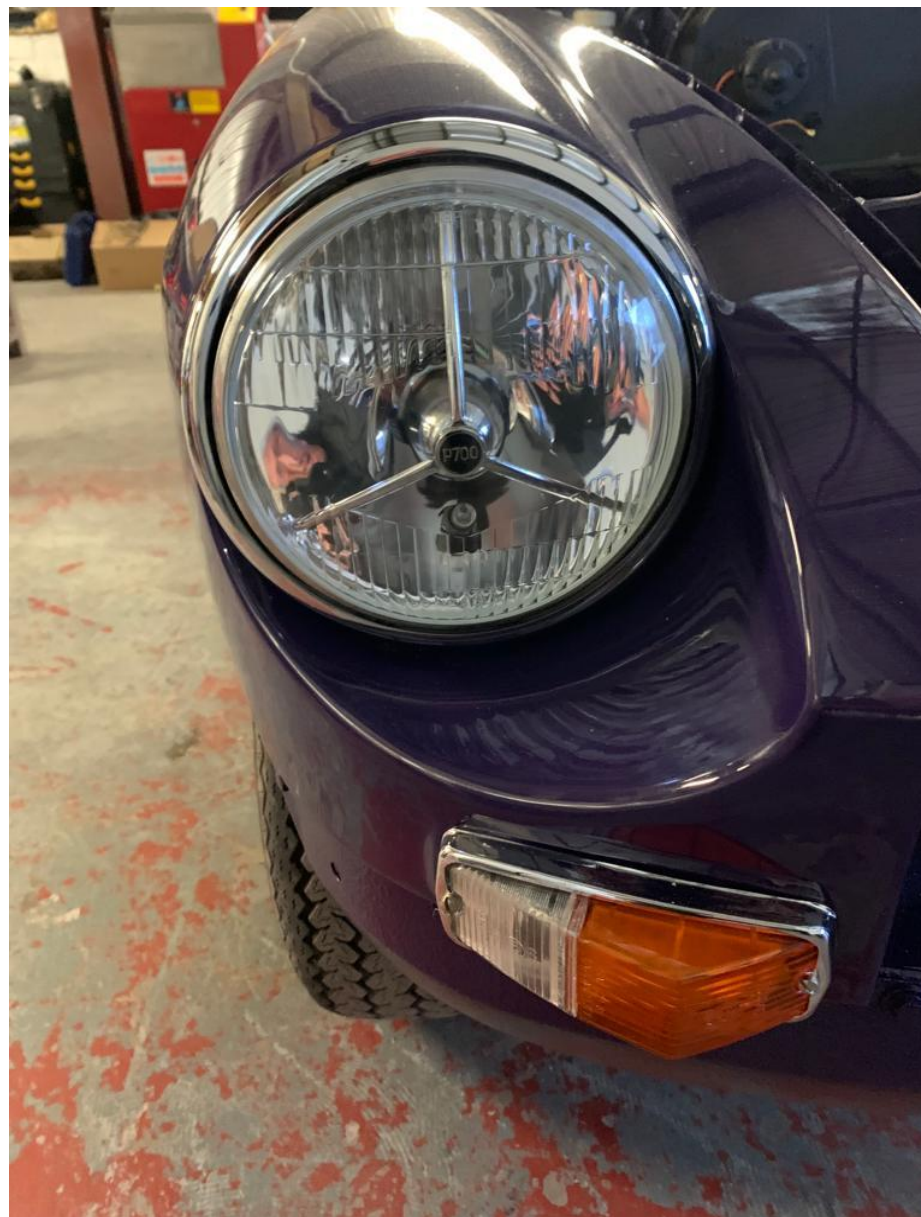
Upgraded front light & side light units fitted – the old sealed beams provide as much head lighting as candles! An upgrade well worth making.

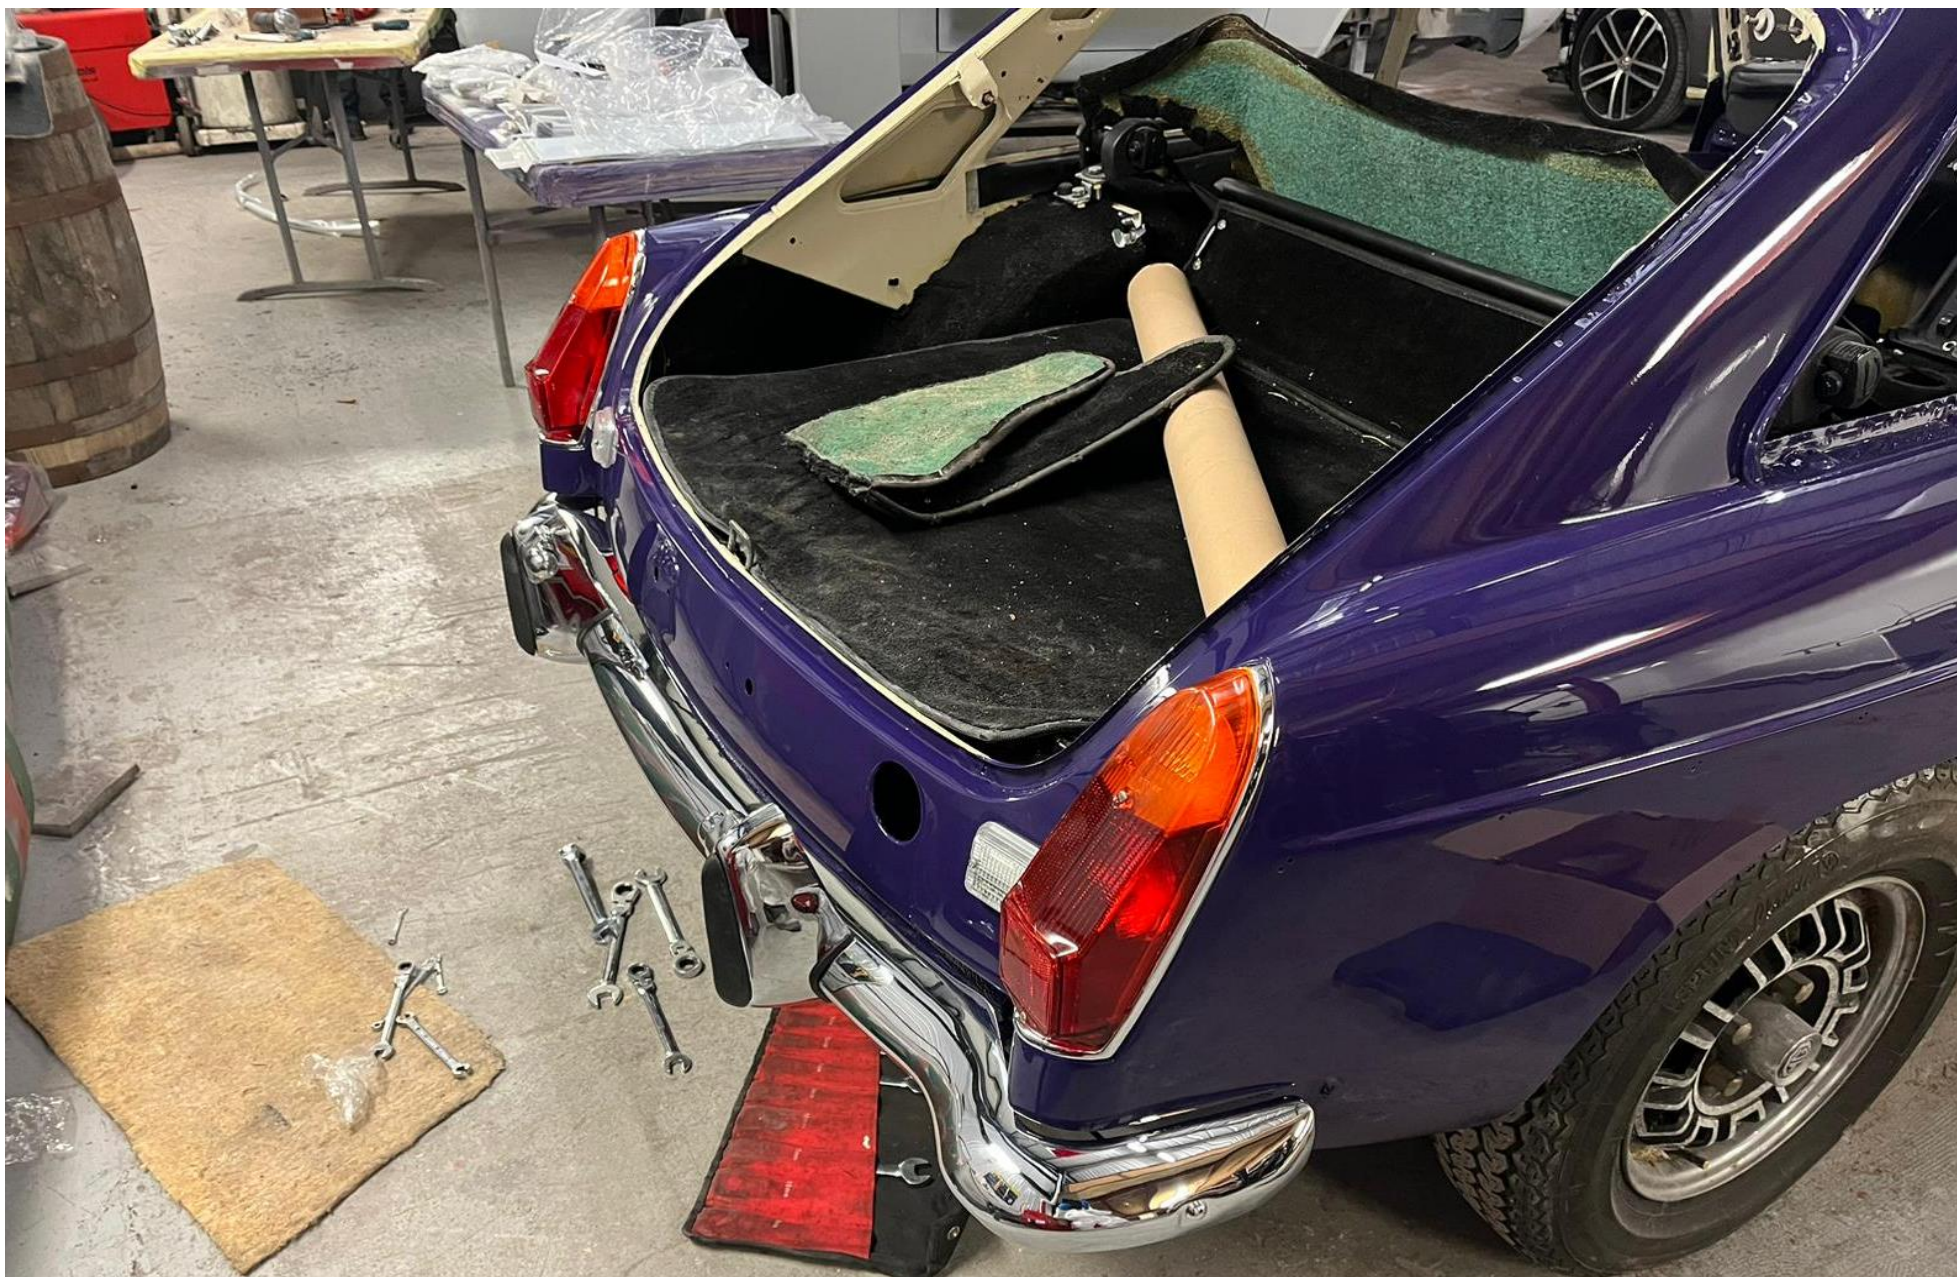
Following the respray the rebuild is progressing well with refitting the re-chromed rear bumper, the rear light units, reversing lights and the headlights too. Inside the carpet trim on and around the luggage platform is progressing and the rear bench seat back is now reinstalled together with the recoil seat belts.
