# WELCOME TO THE V8 NEWSLETTER

## The rebirth of an RV8

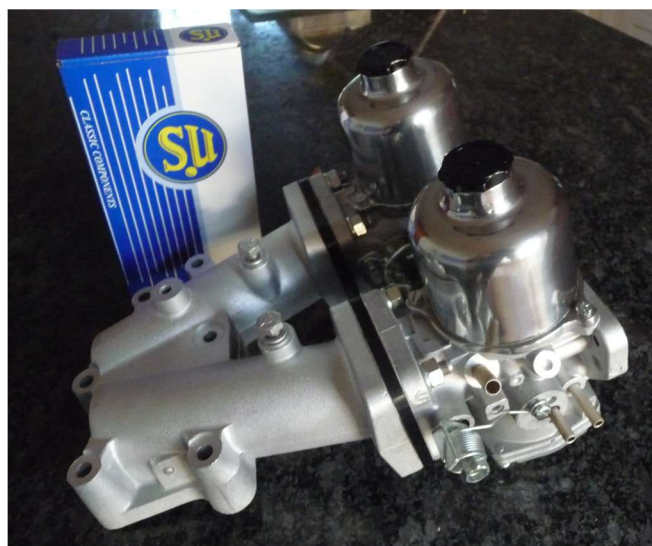
now running normally. However, the exhaust did emit a lot of smoke and smuts on the initial start-up but all is fine now. Andrew Turner advised that the O rings on the choke jets were in very poor condition, I can only conclude that too much fuel was suddenly being forced through the choke jets and flooded the engine to the point where it would not fire despite an adequate spark.

*Richard's refurbished SU Carbs, prior to refitting*

In the absence of any other avenue and a strong smell of petrol on trying to start the engine, I removed the carburettors and had them rebuilt by Andrew Turner, locally to me; they were returned in superb order and refitted, Hay presto! After some coughing and backfiring the engine is

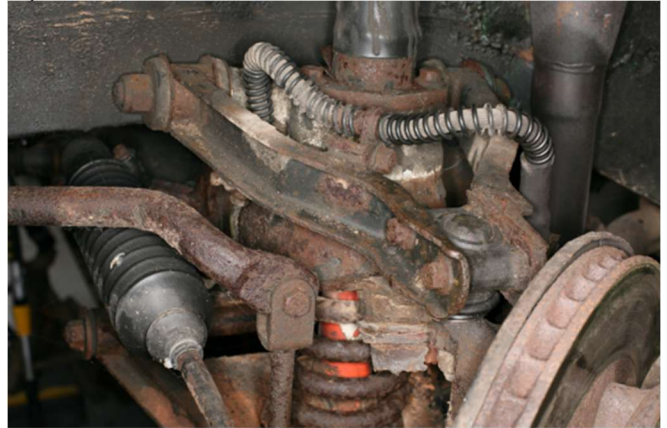
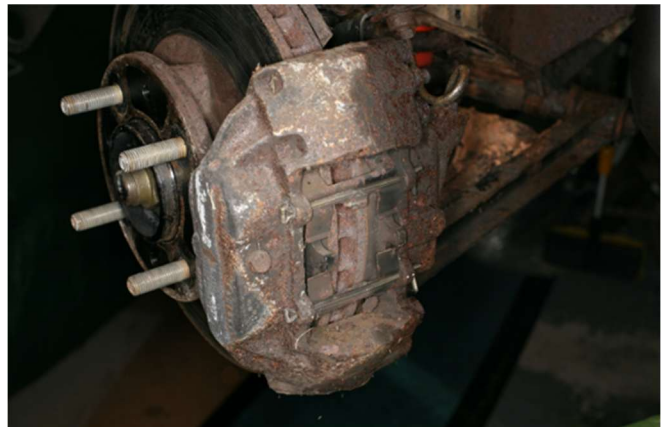
engine. In order to repair this area to a good standard the engine would have to come out and once you start this journey you fall down the inevitable 'rabbit hole' and just keep going! There was also a lot of surface rust on most of the suspension components and the underside was generally in poor condition. The brake calipers had been mentioned in previous MoTs and the service history as being prone to seizing. Again, the condition was poor and would require dismantling and a complete overall or replacement.

*Front suspension and calliper condition, prior to dismantling.*

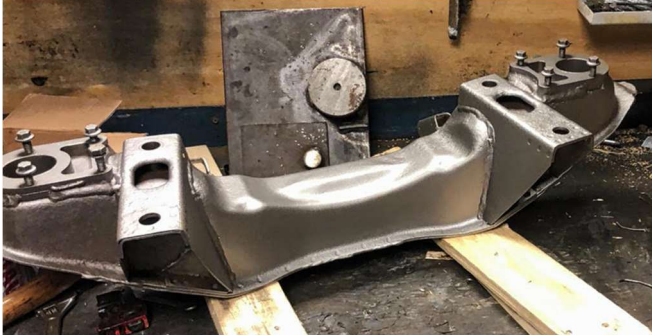
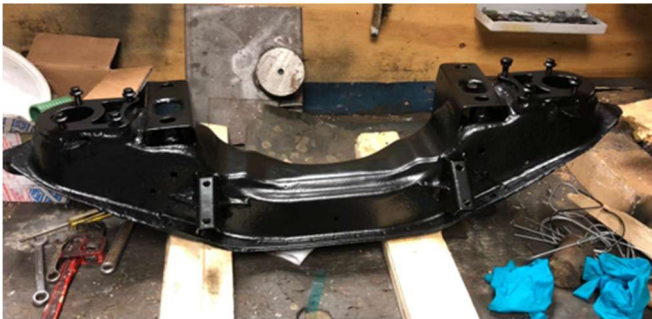
By April that year with the engine and gearbox removed the engine bay corrosion and general detritus could be clearly seen. The engine bay was completely stripped in order to replace or refurbish everything that needed attention. There

was surface corrosion to the bulkhead components, the expansion tank, heater box and pedal box mounting plates. The front axle and suspension components were sent away for shot blasting and powder coating. A recommended modification was also carried out at this stage to the steering rack mounting points to prevent them from cracking in the future. All powder coated components were subjected to an electro plating / painting process prior to the powder coating being applied for durability purposes.

With the engine and gearbox out, the necessary repairs could be made. The inner wing corrosion around the exhaust manifolds was cut out and fresh metal let in and finished back to factory standard, including replacing the spot weld marks correctly. The full engine bay and front wheel arches were then stripped to bare metal, treated with a rust preventative, undercoated with etch primer, seam sealed and given a coat of correct BRG metallic paint. Next the underside was stripped, cleaned, treated with a rust preventative (Jenolite), seam sealed and sprayed with anti-stone chip primer. It was then painted over with Rustoleum combi-colour, mixed to BRG.
