What does a corroded Dunlop composite wheel look like?

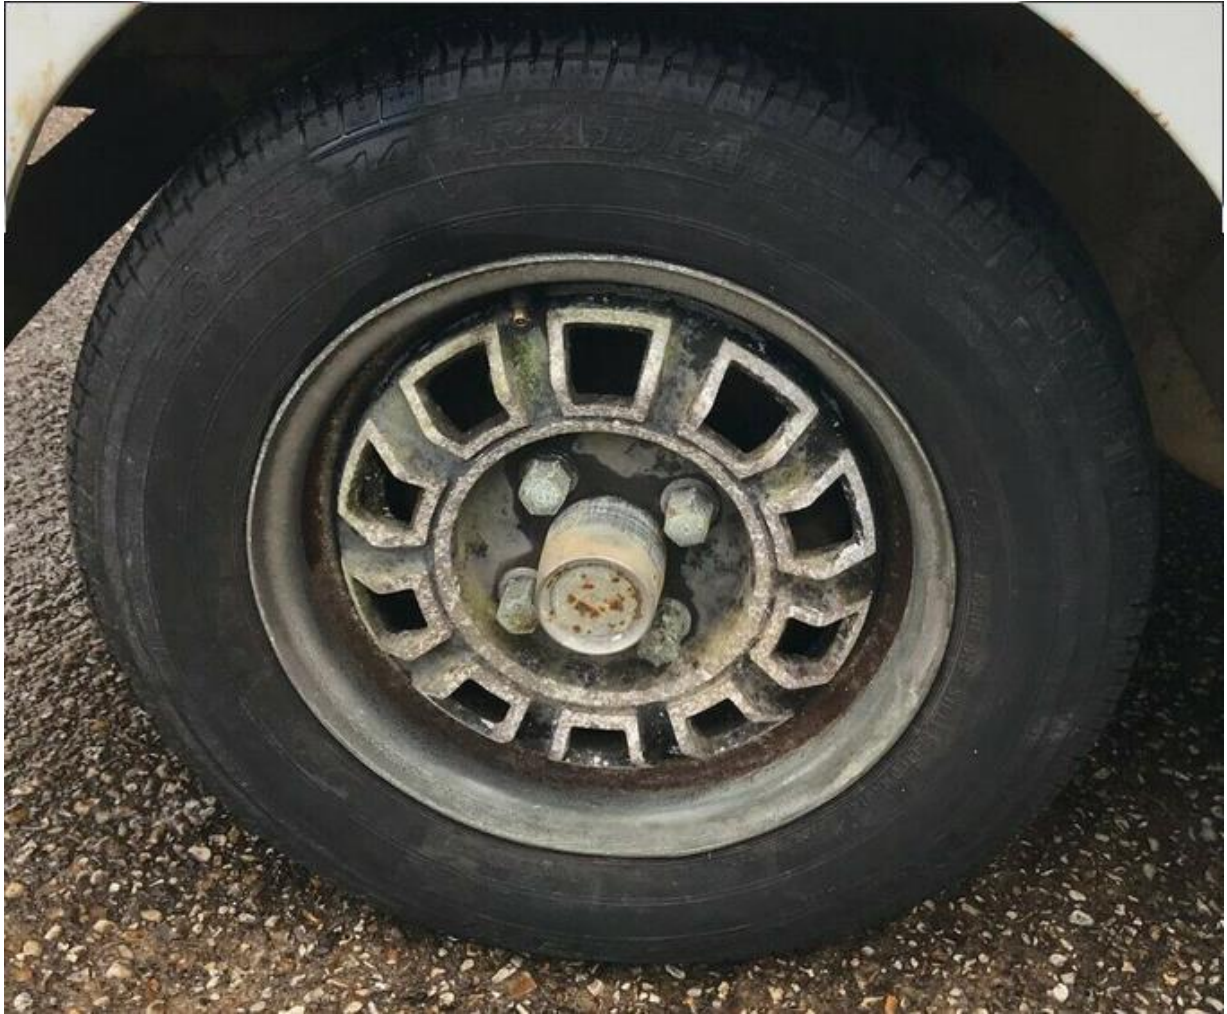
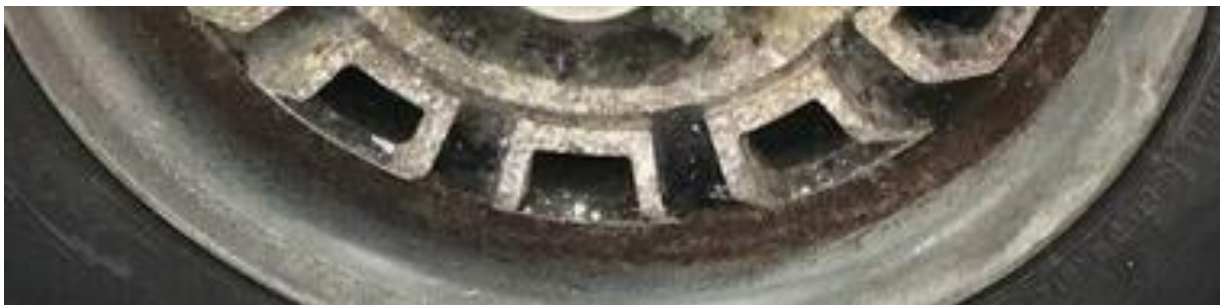
Above is an example of a Dunlop composite wheel on an MGBGTV8 “barn find” which was in a seriously corroded condition. The chromed steel rim is looking rough and the section of the rim near the alloy centre is particularly corroded.
