## Different rear panel joints on Factory MGBGTV8s

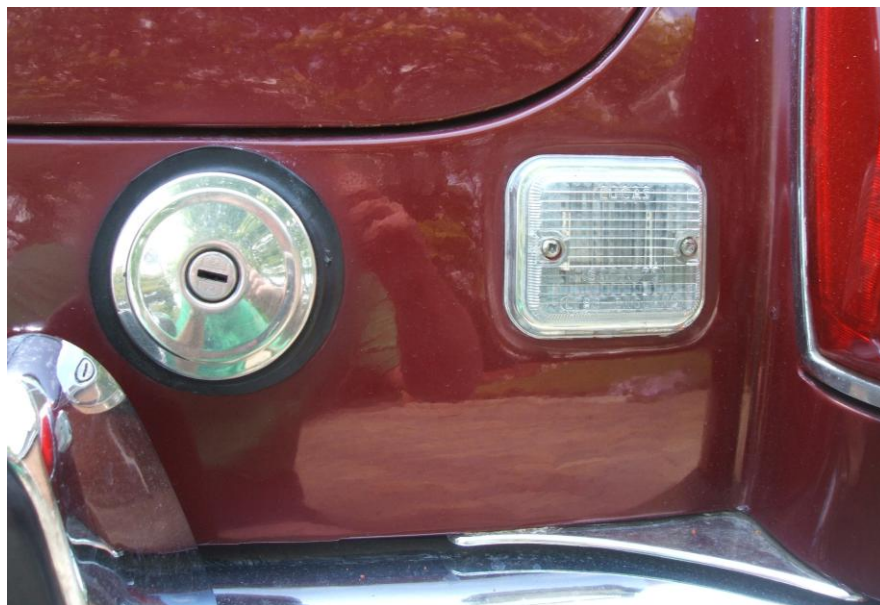
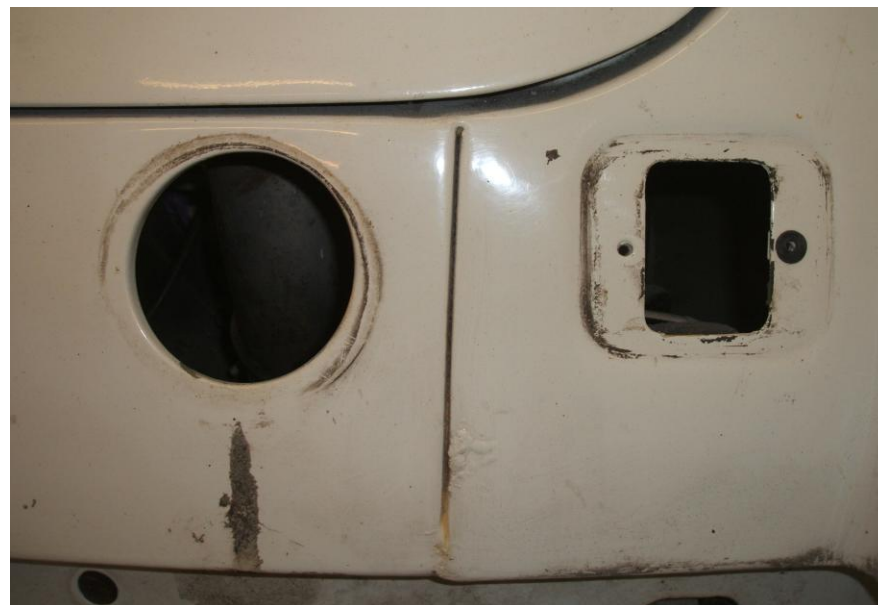
1973 Factory MGBGTV8 in Damask

Michael O'Leary has sent in these comparative photos saying "as described in the V8BB posts the position and type of the joints are different on the two cars - the '1973 model has a lapped joint directly **in-line with the petrol filler aperture** whilst the 1974 car has a flanged joint **to the side of the filler cap**."
