Faulty piston on a rear wheel brake cylinder

During a recent annual service of an MGBGTV8 and a brake fluid change, one of the pistons on a rear brake wheel cylinder assembly was found to be faulty with a small brake fluid leak. As the rubber seal (or boot) on the cylinder is a tight fit the leak was only found when the mechanic lifted the edge of each rubber seal and could see inside each seal. He spotted one seal had the brake fluid leak which had mixed with corrosion muck (see below). It had not been visible from outside with the rubber seal in place because of the tight fit of the seal.

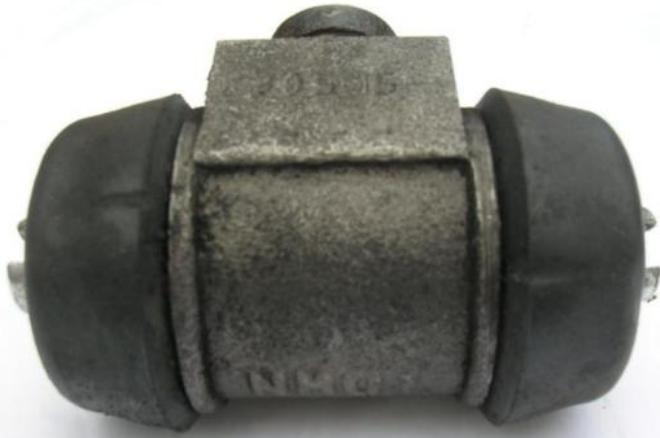
Rear brake wheel cylinder assembly with seals at each end

Both MGBGTV8 rear wheel brake cylinders were replaced and the brake fluid change was completed.

Catalogues and manuals often refer to a rubber seal as a "dust shield". It is recommended that to avoid future corrosion issues the void behind the dust shield is packed with red rubber grease or silicone grease to avoid water ingress and corrosion. Fortunately with the MGRV8 the wheel cylinder is located at the top of the drum so is less susceptible to water penetration when the car is wading through deep water.

If a brake fluid leakage is apparent the brake shoes should be checked for contamination and replaced if necessary. The rear brakes are an important safety feature of the car and their condition is often overlooked.

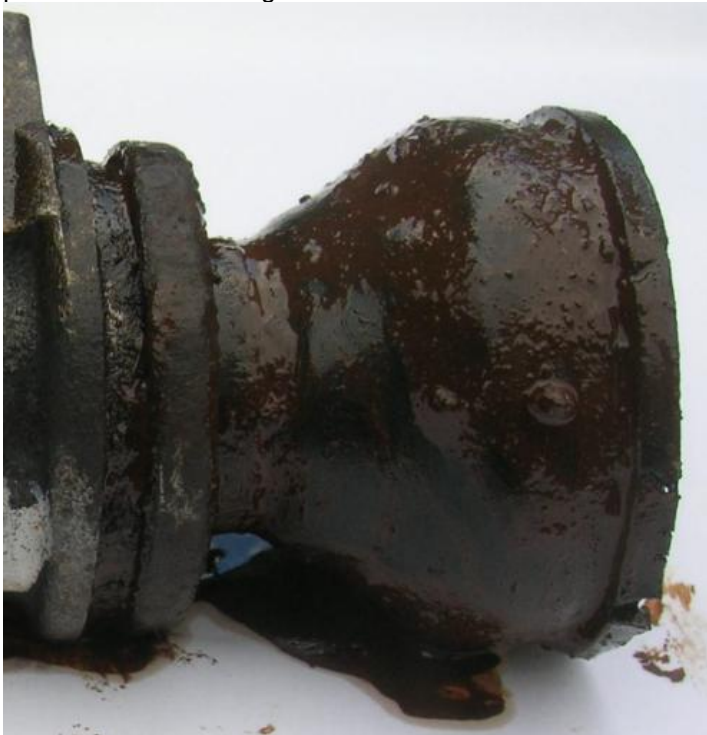
MGRV8 rear brake cylinder & abutment

The arrangement of the rear brake drum components on the MGRV8 is different to that on an MGBGTV8. The main difference is the rear wheel cylinder assembly (5) is at the

top rather than at the bottom of the drum. At the lower point is a fixed abutment (14).

Fortunately with the MGRV8 the wheel cylinder is located at the top of the drum, unlike the MGBGTV8 where the cylinder is located lower down in the drum. So on the MGRV8 a cylinder is less susceptible to water penetration when the car is wading through deep water. See RV8 rear brake drum components above.
