Changing the small bulb in the RV8 dashboard boot release switch

During the discussion of how to solve a faulty luggage compartment lamp switch in the boot lock, Godfrey Dennis also checked the tell-tale light in the dashboard switch which opens the boot. Here he describes how he tracked down a source of the small replacement bulbs and fitted one to his switch. (Aug 12)

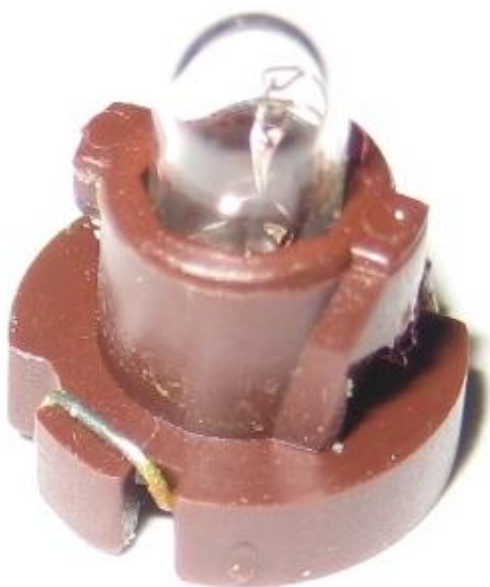
There are actually two tiny bulbs in this dashboard switch so I have attached some photos of the diode bulbs in their holders, removed from the switch. The bulb can be removed from the holder by careful use of a pair of tweezers and then the replacement is self explanatory.

The specialist bulb company for classic cars listed in the V8LIFELINE - Albert Brock Classic Bulbs - do not stock these small diode bulbs, but I have found that high street and online electronics shop Maplin does. The part or catalogue number at Maplin is **BT43W** and they each cost about £1.30.

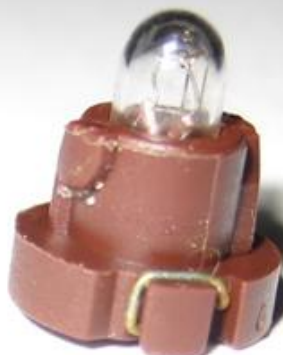
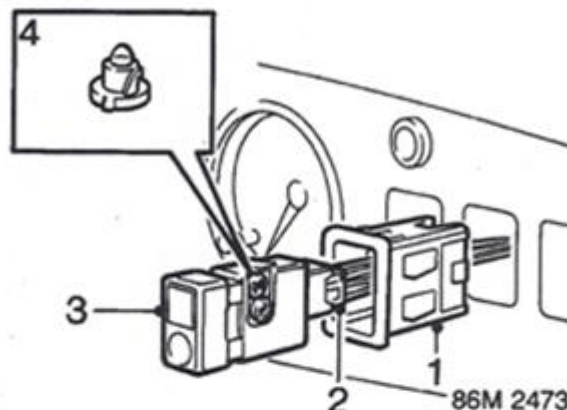
SWITCH AND BULB

1. Ease switch holder from fascia panel.

Note: RH switches can be pressed out by reaching behind panel.

2. Disconnect multiplug from switch.
- Do not carry out further dismantling if component is removed for access only**
3. Remove switch from holder – not Hazard switch.
4. Remove bulb(s) from switch.

1. Fit new bulb(s) to switch.
2. Fit switch to holder – not Hazard switch.
3. Connect multiplug to switch.
4. Align and press switch holder into fascia panel.
