Modification so your temperature gauge has an accurate reading

Your RV8 temperature gauge is lying!

Stefan Matthaei (Woodcote Green 1250) from Munich in Germany suggests a simple modification on the wiring of the temperature gauge to allow for correct readings of the engine temperature. (Jun 04)

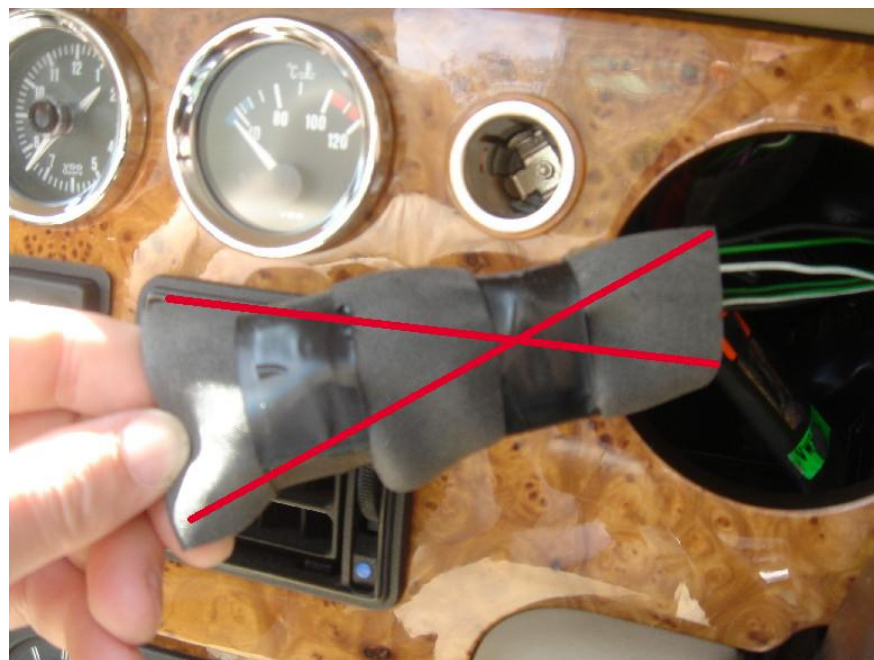
Temperature gauge ECU? No this is NOT THE RIGHT THING; this is in fact the dampening ECU for the fuel gauge. (Photo: Stefan Matthaei)

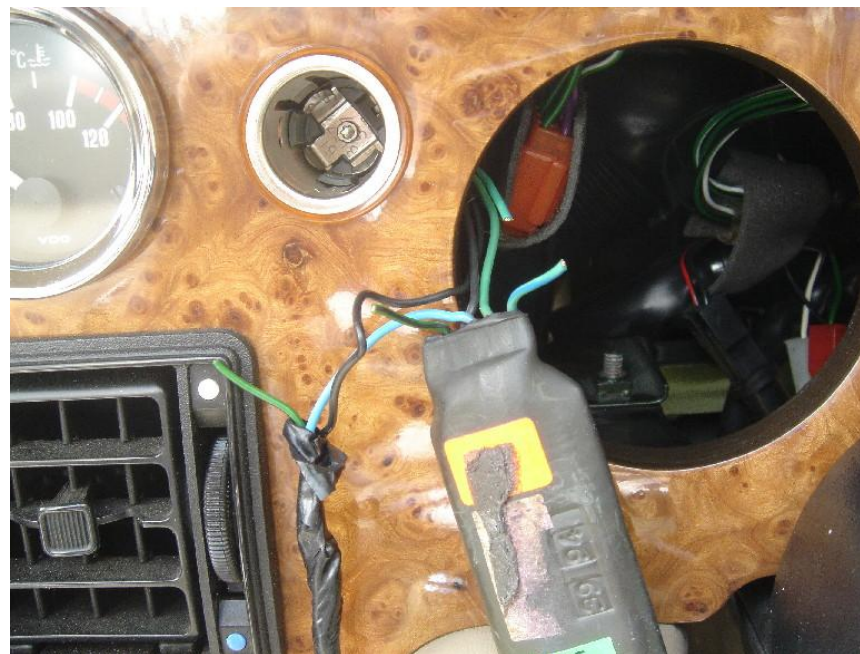
Temperature gauge ECU. (Photo: Stefan Matthaei)

Note 206. The ECU is basically behind the dashboard just loosely attached to some wires. You can find it easily if you remove the tachometer and then detach the cable from the back of the temperature gauge. Be careful to note the orientation of the connector!

The **temperature gauge ECU** is completely sealed in hard plastic. The photo below shows the unit with **step one** of the modification already completed. Cut the Green-Blue wire coming in and the Green-Black leading to gauge but do not cut them too short, in case you ever want to revert back. In fact for easier access, the whole thing can be disconnected from the wiring loom completely. The white connector shown below sits right above the tachometer hole on the back of the dashboard. The photo below shows **step two** of the modification, connect the Green-Blue wire coming in and the Green-Black leading to Gauge directly, insulate remaining ends on the ECU.

Step three is the straightforward reassembly of this element. You might want to make sure it is attached somewhere and cannot create any rattling noises. It is also worth attaching the fuel dampening ECU with similar care.

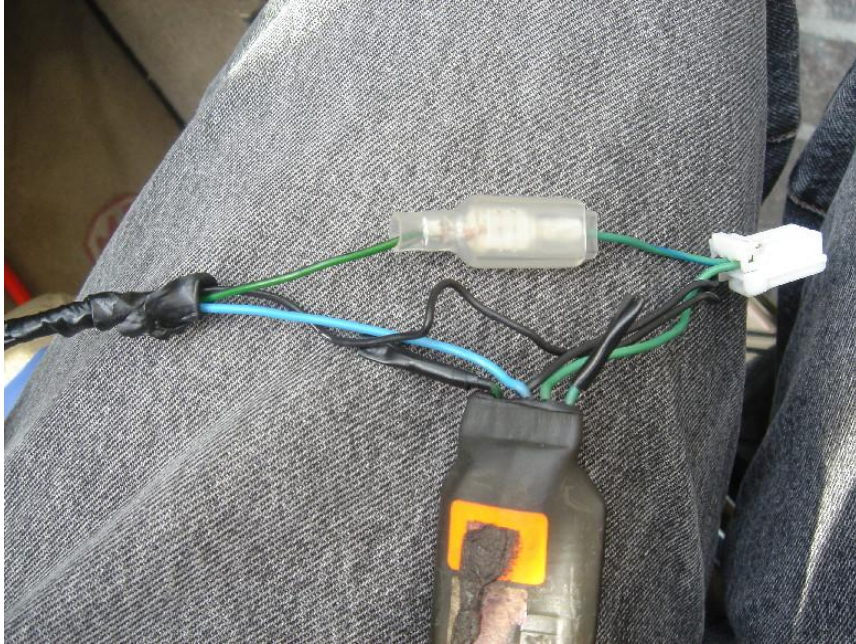
Finding the white connector. (Photo: Stefan Matthaei)
