Not all suspension modifications on an RV8 are a good idea

Contributed by Angus Munro

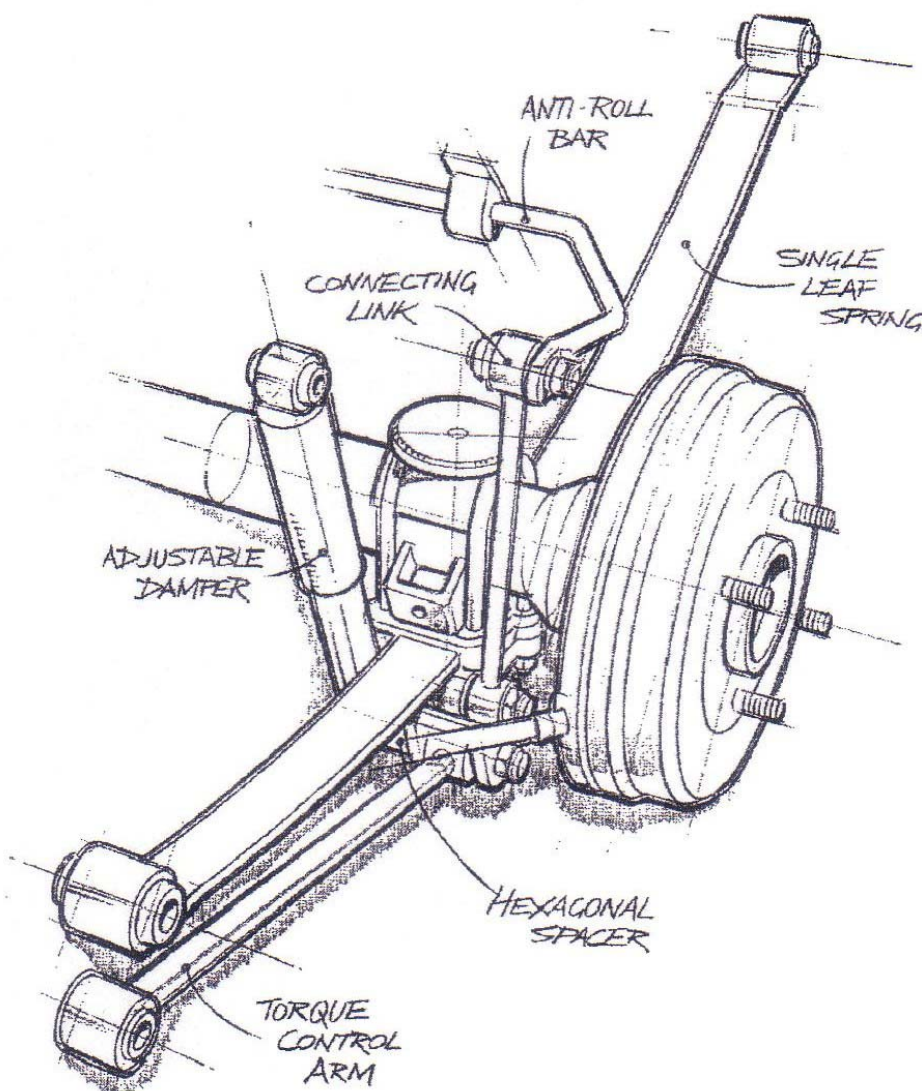
Note: RV8 rear suspension sketch is from the Technical Reveal for the RV8: Rover.

These days most people refer to torque control arms as anti-tramp bars. They were fitted as standard equipment on the RV8 to prevent the leaf springs winding up during acceleration. Due to torque it is always the right hand spring that shortens in an "S" shape in front of the rear axle. The righthand side suffers more because the torque reaction in the propshaft applies force to lift the righthand rear wheel off the ground. So unless a limited slip differential is fitted, the righthand wheel always spins first. The RV8 has a type of LSD fitted - a Quaife - which is known as a torque biasing unit and it will only work when both wheels are in contact with the ground. As soon as one wheel is in the air it loses the opportunity to bias the torque.

Without torque control arms fitted, what are the effects on the handling of an RV8? Well under acceleration the shortened 'S' shape of the spring results in fore and aft movement of the back axle which tries to try to steer the rear of the car to the left. A sudden lift off would have the opposite effect, causing the rear of the car to try to steer to the right and causing the car to swerve to the left of track. That is the effect Angus Munro describes above as his experience when driving with the suspension modifications fitted to the RV8 he had bought. With the combined effect of no torque control arms and only minimal positive castor angle worth speaking of, he is thankful the results were not more calamitous!

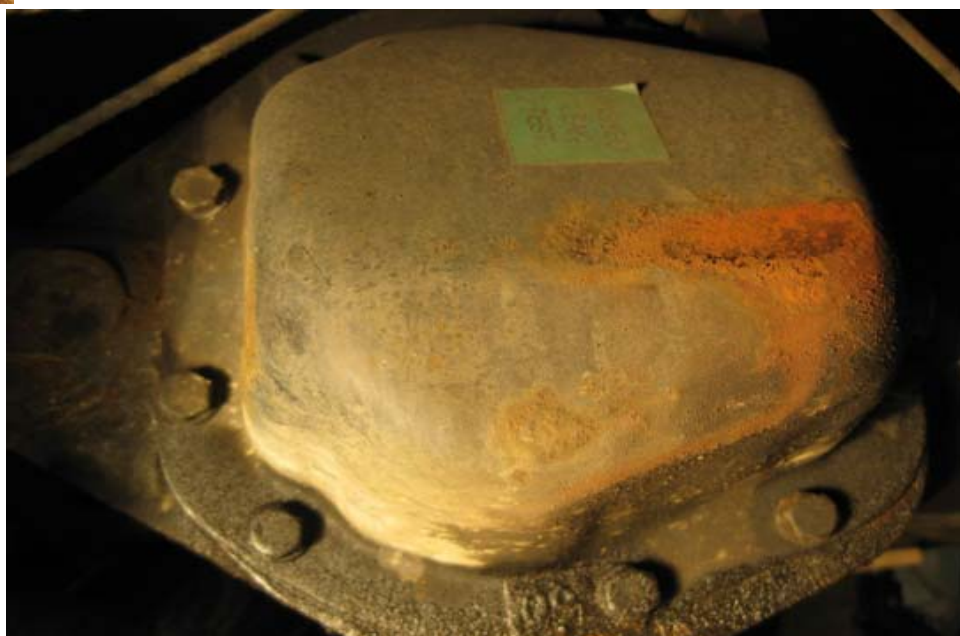
Above: Differential with the impact marks from the Panhard rod: a long mark to the right and a spot mark which was shiny two months earlier. (Photo: Angus Munro)

you seen this?" inquired my mechanic pointing out a bright and shiny spot on the rear differential case. "And this?" pointing out a bright and shiny flat on the inside of the Panhard rod. Clearly the Panhard rod was in contact with the differential casing. So as there is no position adjustment possible, I got my eagle eyed mechanic to remove the Panhard rod.

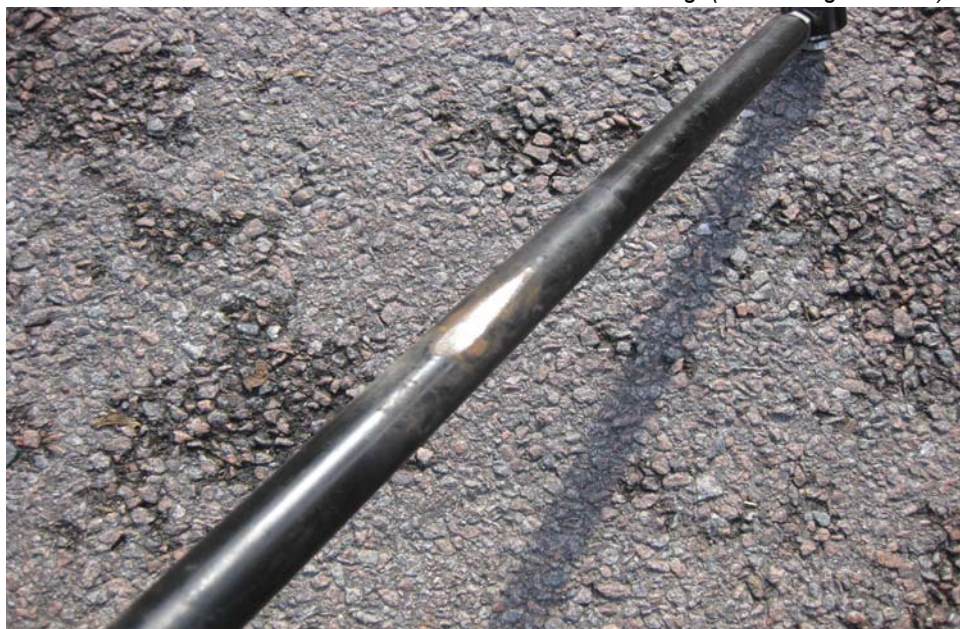
Panhard rod polished from friction contact with the diff casing. (Photo: Angus Munro)
