Surprise on opening up an MGBGTV8 back axle!

Peter Nixon is restoring a V8 Roadster with a V8 conversion. It has had the restored shell resprayed in one colour throughout. He has been two pack primed throughout with new panels, the underside stone chipped and then a final paint in Pageant Blue. In July 2019 he found a secondhand MGBGTV8 back axle and on checking it before installation was surprised by what he found. Fellow members will note his reminder – “Does your MGB differential have a “clunk” sound when you start moving?”

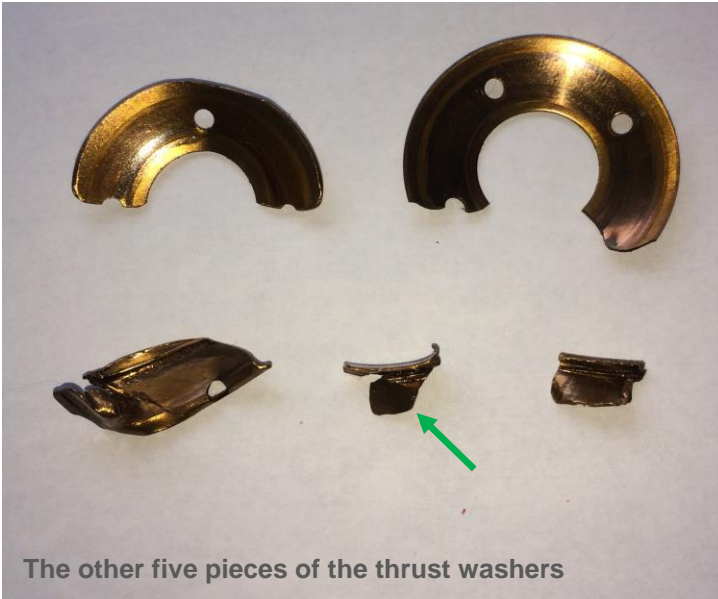
The other five pieces of the thrust washers

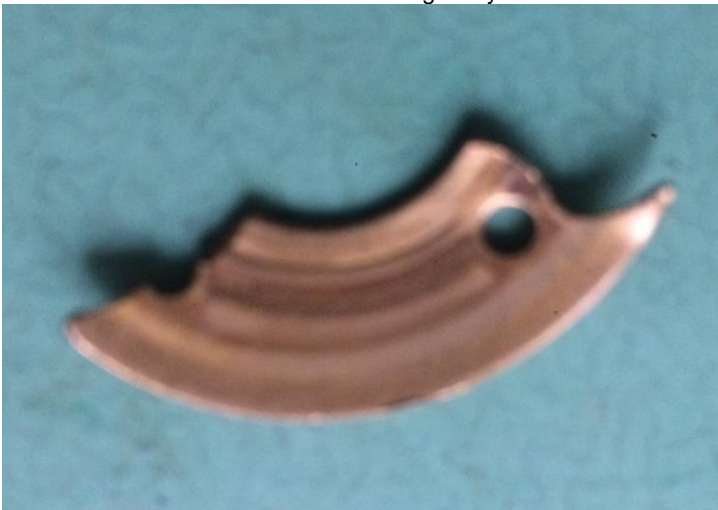
Broken piece of a thrust washer

I was about to fit the secondhand MGBGTV8 ratio rear axle to the MGB Roadster shell that I bought for my SD1 V8 conversion and opened up the back axle to inspect the gearing and to confirm it was a V8 3.07 differential. It was then I noticed a broken piece of a bronze thrust washer from the planet gears lying in the oil - not what one wants to see. Using a screwdriver I could move the planet gears by about a millimetre on the pinion shaft, so obviously this called for new thrust washers to be fitted. As the remains of the planet gear thrust washers had signs of wear, there would also be wear in the sun gearing thrust washers, this wear would produce a noticeable clunk from the rear on moving away.

The first piece of a planet gear thrust washer found.

We re-assembled the differential gearing with the planet gear thrust washers, to eliminate the wear in the sun gears required a 40 thou and a 48 thou bronze thrust washer to be fitted. After fitting the new roll pin we tried to insert the 7/64" split pin into the roll pin, but it was proved too big as the roll pin had closed up, it fitted into the roll pin before the roll pin was fitted - I am not sure it is really necessary as the roll pin had to be driven in with a hammer and punch.

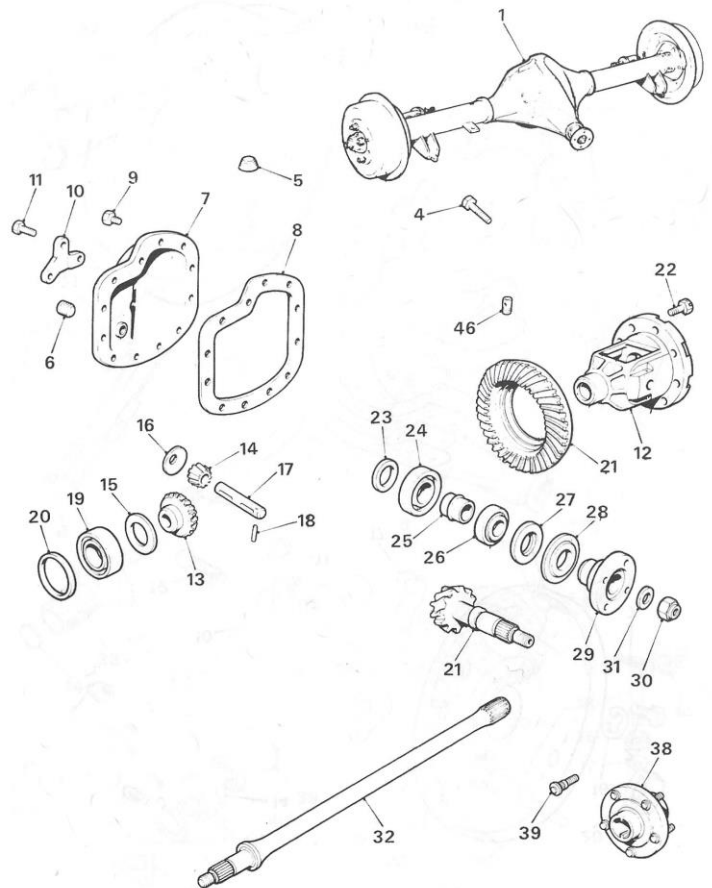
16	1G7445	Washer, thrust pinion
15	ATB7072	Washer, thrust pinion
36	GHS179	Axle oil seal
18	BTB7159	Roll pin
15	ATB7072	Wear take up washers
	GHF505	Split pin

Looking at the MGB parts catalogue, I could see the thrust washers for the planet gears, the fibre washers for the sun gears, and the oil seals in the wheel hubs. Talking to Moss Europe they said there are three thicknesses of bronze washers available to take up wear in the sun gears, so I ordered all three pairs, plus the thrust washers for the planet gears, the oil seals, the roll pin and a 7/64" split pin as noted in the V8 Workshop Notes. See [V8NOTE98](#)

Planet gear thrust washer, supplied in pairs	1G7445
Sun gear fibre washer, supplied in pairs	ATB7072
Axle oil seal, supplied in pairs.	GHS179
Roll pin.	BTB7159
Wear take-up washers, 35 thou standard, supplied in pairs	ATB7072
Wear take-up washers, 40 thou (+0.005"), supplied in pairs	ATB7072
Wear take-up washers, 48 thou (+0.013"), supplied in pairs	ATB7072
Split pin, 7/64" dia	GHF505

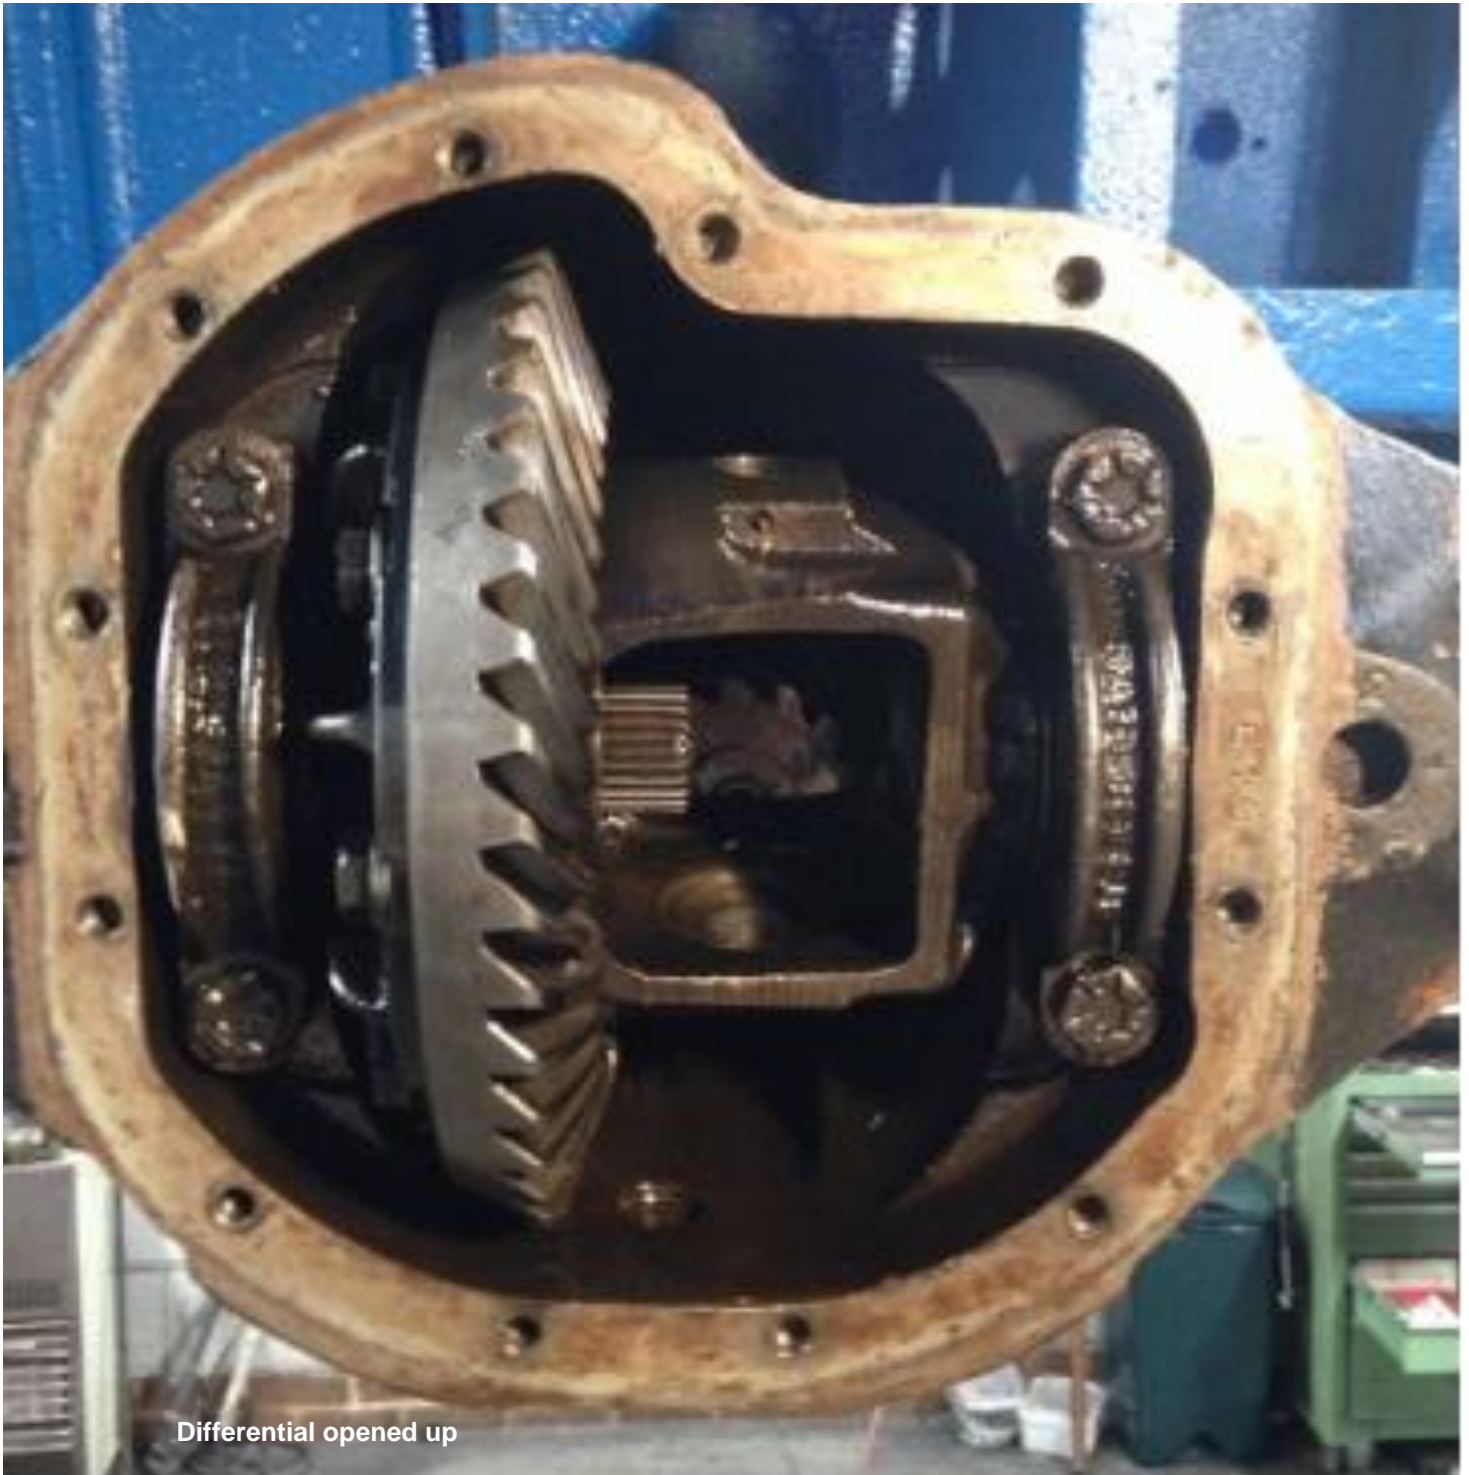
Differential opened up

More thrust washer pieces emerge

Draining the hypoid oil, four further pieces of the two planet thrust washers were found. On stripping down the brake hubs to be able to get at the drive shaft to free off the sun gears, a further piece of a planet thrust washer - the middle small piece in the lower line of the photo at the head of the article - was found embedded in the left side outer oil seal, having worked its way through the differential half shaft bearing, along the axle tube, through the wheel bearing

into left side oil seal, effectively destroying the oil seal. We checked the bearings, they seemed fine.

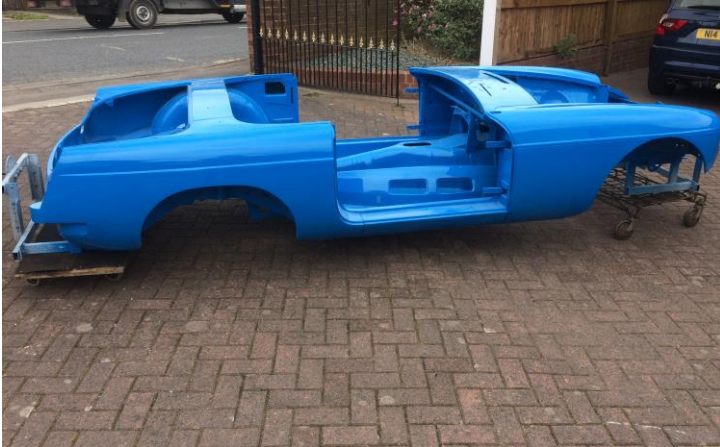
V8 Roadster shell

The photo above is of my bead blasted two pack primed fully repaired and painted 1980 MGB Roadster shell still on the rotisserie frame and about to have the suspension, brakes, V8 dashboard, windscreen, the new V8 front wiring harness, new GT rear harness and a set of old Rostyles wheels installed.

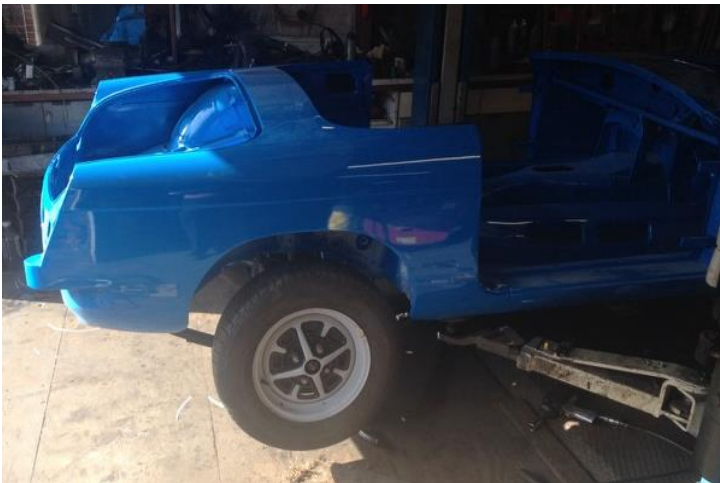
The photo below is the rear end of the MGB assembled.

We then fitted the new oil seals in the wheel hubs, re-assembling the drum brakes, fitting new rear MGB Roadster brake cylinders as the axle originated in a chrome bumper GT it had bigger brake cylinders, these would cause the roadster rear brakes to lock-up as my rubber bumper to roadster chrome bumper conversion rear has less weight to carry than a chrome bumper GT. Hopefully this fix will last 150,000 miles.

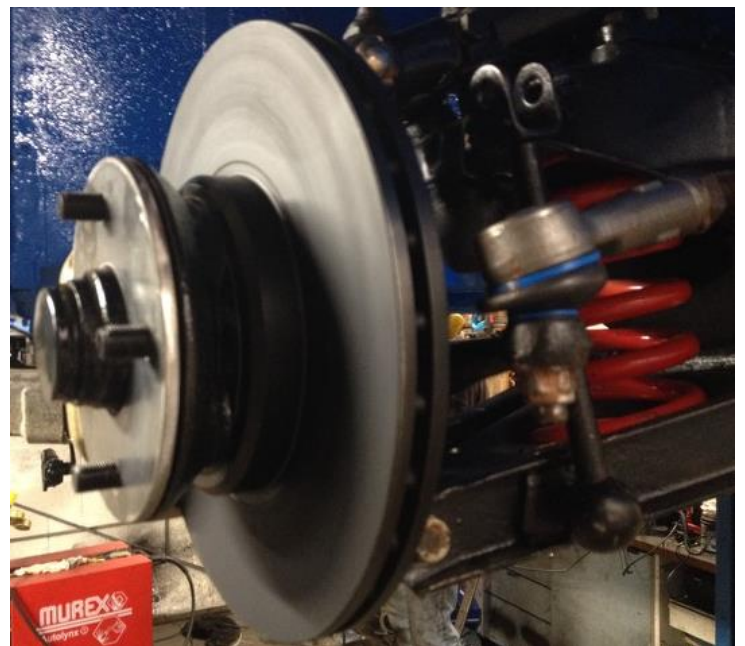
Room for Princess calipers

I spoke with Roger Parker and he confirmed that the old original Rostyles with the 4 mm greater offset would fit over the larger Austin Princess four pot calipers if I used a 6 mm spacer on the front hubs, the four pot calipers have a spacer fitted so they fit over the Peugeot 505 Turbo vented discs I have fitted. The four pots are fitted with a link pipe from the second incoming brake pipe to a bleed vent so they operate with a single brake feed. A local engineering company produced the spacers using laser cutting, the fit is very good, just fitting onto the wheel studs with no play, this company also re-drilled the vented discs to suit the MGB stub bolt hole PCD.
