MGBGTV8 restoration project from David Smith – Report 2

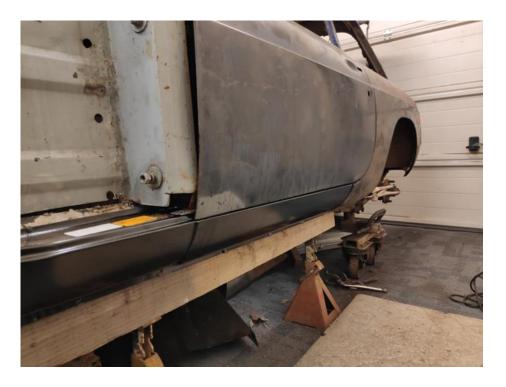
With a good grind and wire brush applied a coat of epoxy sealer to all the inner sections and rear wing internals and trial fitted the rear wing and door. Much better.

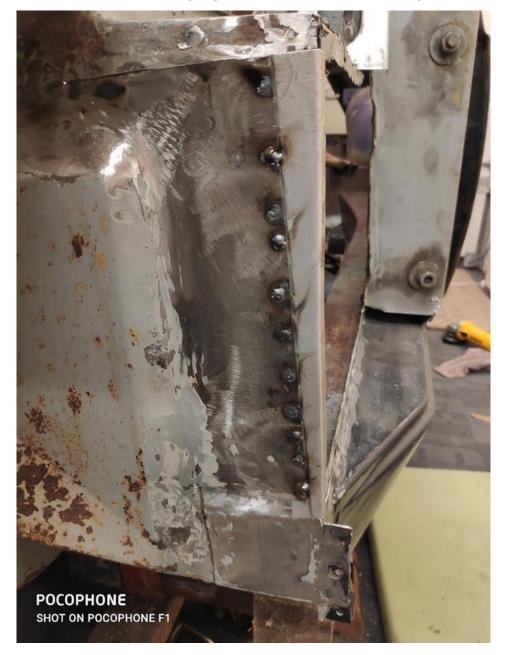
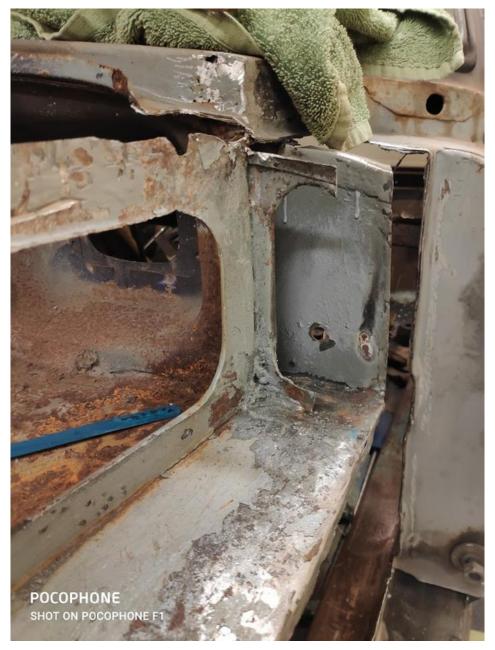
Footwell side in and a bit of wing gutter replaced. Didn't get a photo of the inner wing turret before I got the front wing on for a trail but I can update this later.

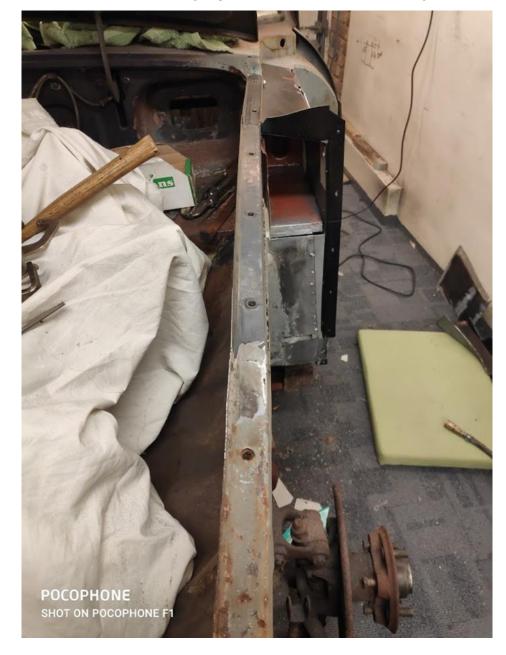
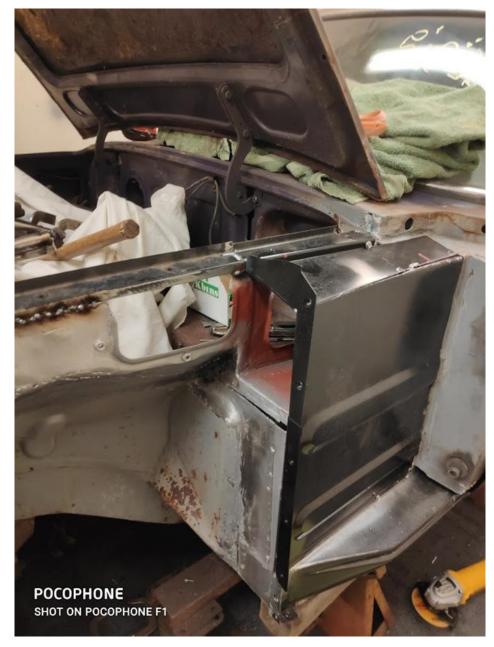
And so on with the front wing, bit of fiddling and adjustment and the wing is on and bolted up tight for now.

Body swage aligns quite well and is fairly straight. What doesn't seem any better though from the BMH panels I used to use years ago and now is the fit and curvature around the wing to sill areas both front and back, and the general curvature of wing to door, however all manageable later on.

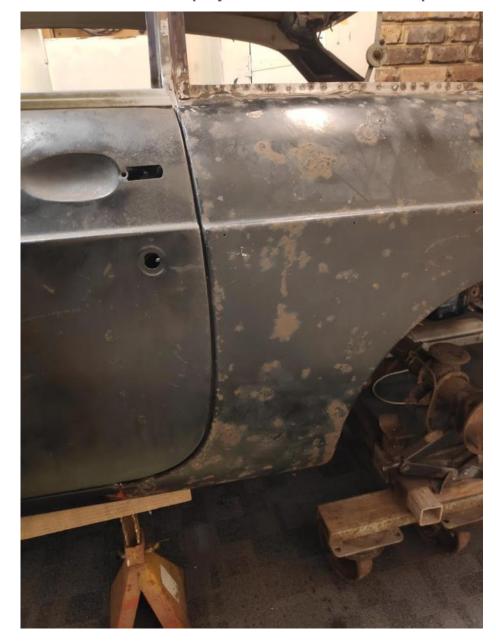
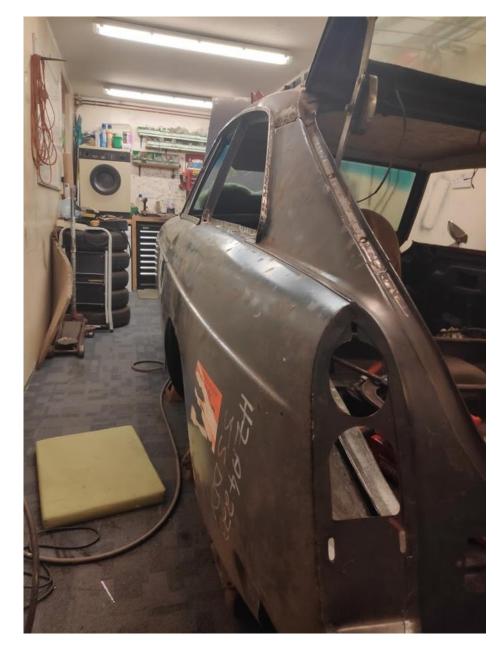
Managed to spotweld the rear on as much as posible, hopefully avoiding the grind and just being able to prep and paint over to give some sort of factory fit. Just the small fillet of the B post to wing to do.

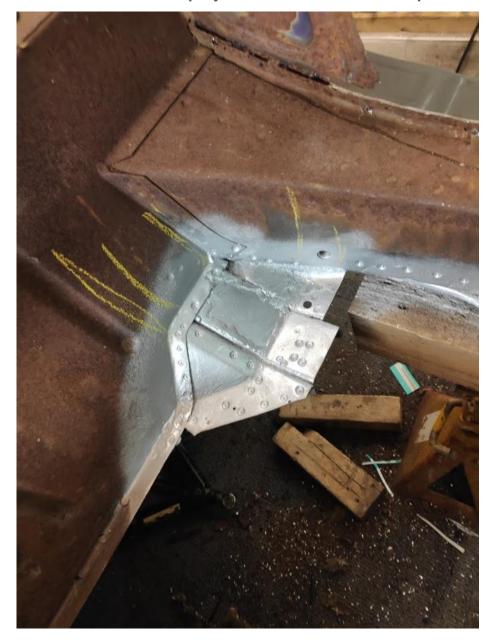
The rear heelboard extension piece was rusty and cut out. Again a where not being welded a coat of epoxy sealer and then on the weld thru edges a coat or zinc weld primer. Also a small section of the spring hanger needed replacing, hadn't rusted thru yet but now it was easier now than later on. Got carried away with the hole punch here but this was almost the same amount that the OE piece had in it, just means a load of grinding coming up.

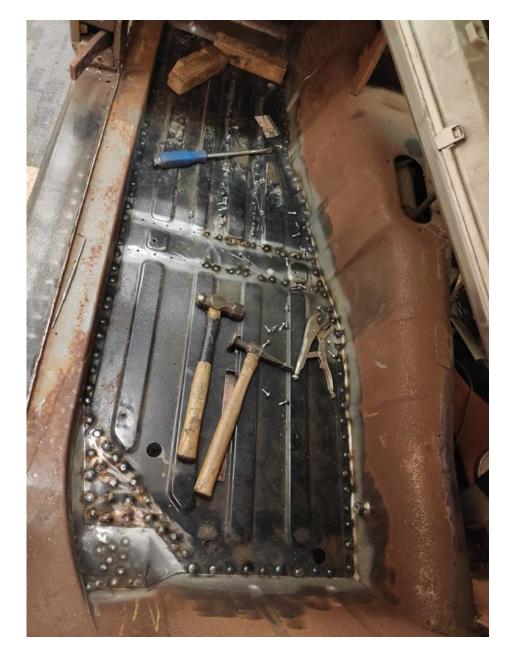
And finally for this side the floor pan. The chassis outrigger leg and jacking point will get done once the car is on the rotisserie, easier that laying on your back with welding splatter rattling about in your ear. Also the obligatory grinding session for the mig plugs in the flor pan.
