RV8 heater rail modification to avoid a heavy indentation on a rubber heater hose

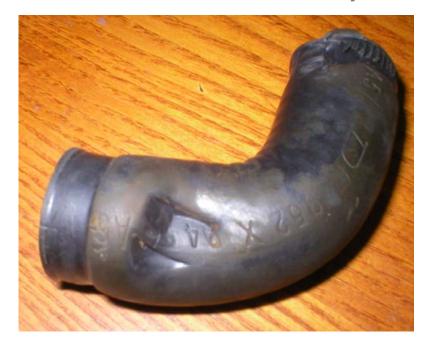
Steve Newton has come across a number of RV8s with an indentation on an elbow shaped rubber heater hose on the end of the heater rail near the alternator. The heavy indentation is made by a bolt head on the alternator cradle pressing against the rubber tubing. Steve says it's not seen on every car so why does it appear on some RV8s?

the manufacture of the heater rails there was some variability in the positioning of the welded brackets on the rail so when the heater rail is bolted down with the fixing bolts, the end of the rail near the alternator is too close to the alternator. So the elbow is pressed up hard against the bolt head on the alternator. The cure is not to bolt up rail to the fixing

It seems that in
