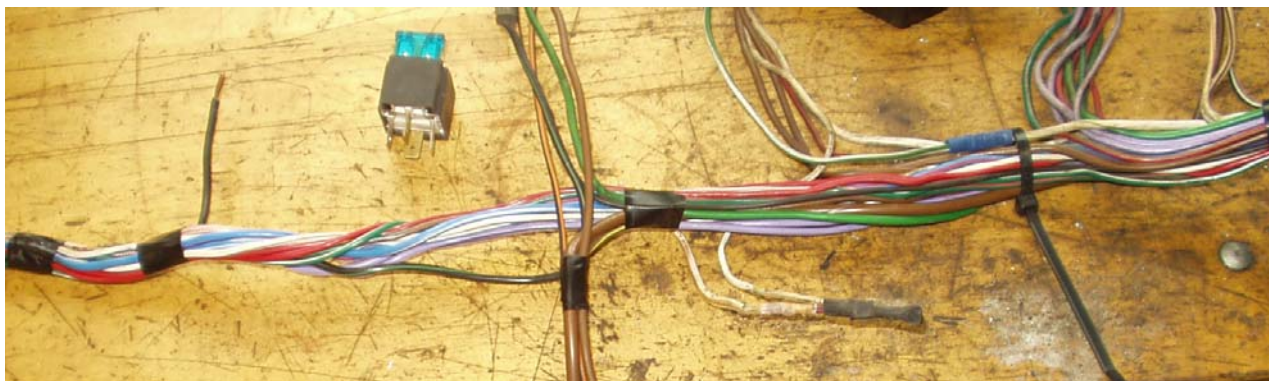
When I removed the outer layer of loom tape, I found evidence within the loom that some extra wires were added by the Factory. Presumably they modified the 1800 loom. For example, the pink resistive ballast wire that powers the coil was found to be taped to the loom and then covered with a second layer of black loom tape - see photo above (Wiring 2). This pink wire will be removed from the loom and replaced with a plain white wire, because I always fit a Pertronix electronic unit inside the distributor, and it requires an un-ballasted 12-volt supply.
