MGBGTV8 rebuild report from Lorraine Noble-Thompson

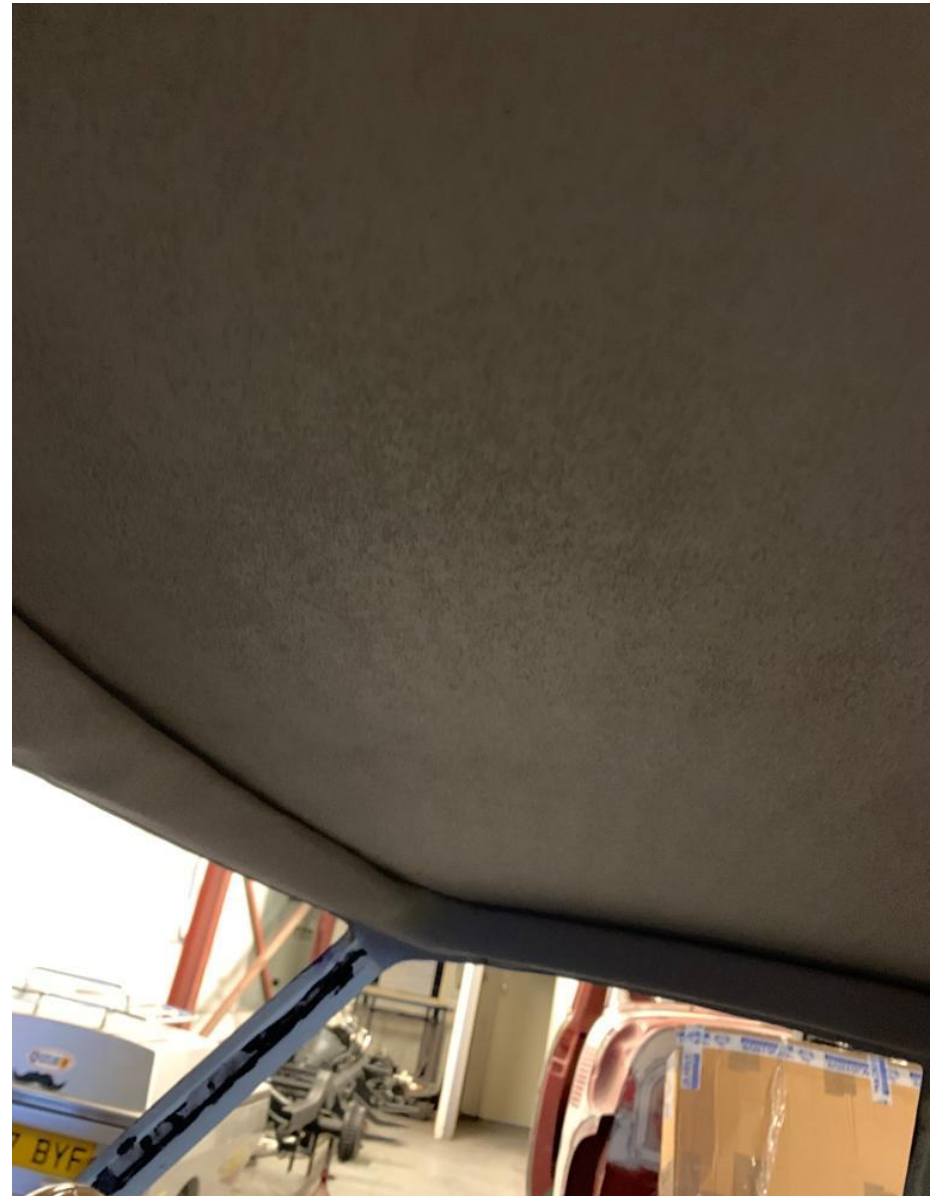
Geoff Allen (who was in Rectifications for 27 years) said fitting the headlining was a difficult task but it now in place. Windscreen & tailgate soon to go in.
