# WELCOME TO THE V8 NEWSLETTER

## The rebirth of an RV8

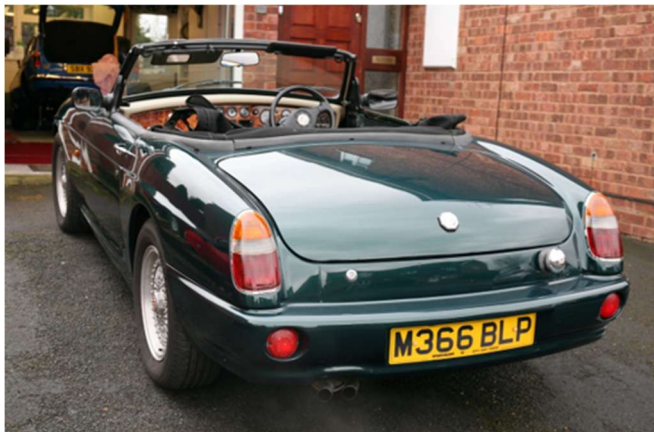
*25/11/2016. The day the RV8 was delivered needing work to get it useable*

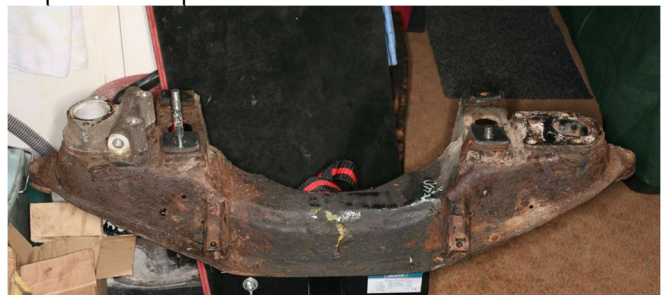
By April that year with the engine and gearbox removed the engine bay corrosion and general detritus could be clearly seen. The engine bay was completely stripped in order to replace or refurbish everything that needed attention. There

was surface corrosion to the bulkhead components, the expansion tank, heater box and pedal box mounting plates. The front axle and suspension components were sent away for shot blasting and powder coating. A recommended modification was also carried out at this stage to the steering rack mounting points to prevent them from cracking in the future. All powder coated components were subjected to an electro plating / painting process prior to the powder coating being applied for durability purposes.
