# REGISTERS

V8

## Leaking Exhaust Manifolds

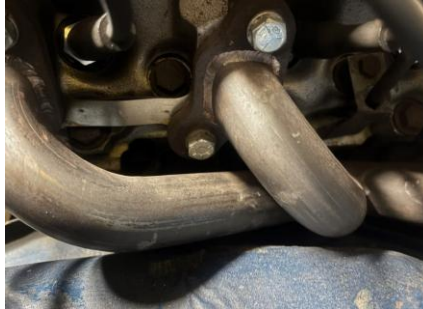
including myself, with varying advice on the type of gasket to use and how to obtain a good (and lasting) seal. Jim Gibson posted that he had used a suitable High Temperature RTV (silicon gasket) with a good level of success, although as he pointed out application can be fiddly and messy. Chris Armitage then posted that he's had similar issues and puts the problem down to modern gaskets no longer containing asbestos and that perhaps modern substitutes are maybe functionally inferior. Chris now adopts a retightening process; firstly, after the initial heat cycle and then again after a few miles and once more after a few weeks. Chris reports that the bolts usually need a 'bit of a nip-up' on each occasion but further reports that after 2/3 'nips' he has never had them leak – although they always used to in the

past before he adopted this practice. Chris also states that the manifold to exhaust nuts also need nipping up in the same way, although the caveat stated above regarding the flange fragility on cast manifolds (which Chris's car has) should always be borne in mind. Food for thought if you have experienced leaking manifolds.

Many MGBGT V8s have now been fitted with stainless steel tubular exhaust manifolds, as the original, factory-fitted cast iron items were quite 'fragile'. Extreme care must be taken with them as they are prone to cracking (on the driver's side by rubbing against the steering column), and generally by overtightening at the lower end when fitting to the exhaust system. Replacement s/s tubular manifolds offer a number of advantages, such as durability, improved exhaust gas flow, etc. but they do have a tendency to lose shape across the mating face with the cylinder head due to the extreme temperatures, plus the fact that they are a series of tubes welded together, rather than a single piece, such as the original cast iron items. A number of members have experienced 'leaking' exhaust manifolds, due to the tendency for the flanges to move. Mike Howlett posted on the V8BB recently with this problem and a number of people responded,
