## Take care with excessive use of sump sealant – RV8NOTE339

On checking an RV8 for a sump oil leak, Steve Newton at Clive Wheatley mgv8parts was surprised by what he found! It could easily have lead to an expensive engine rebuild. (Jan 11)

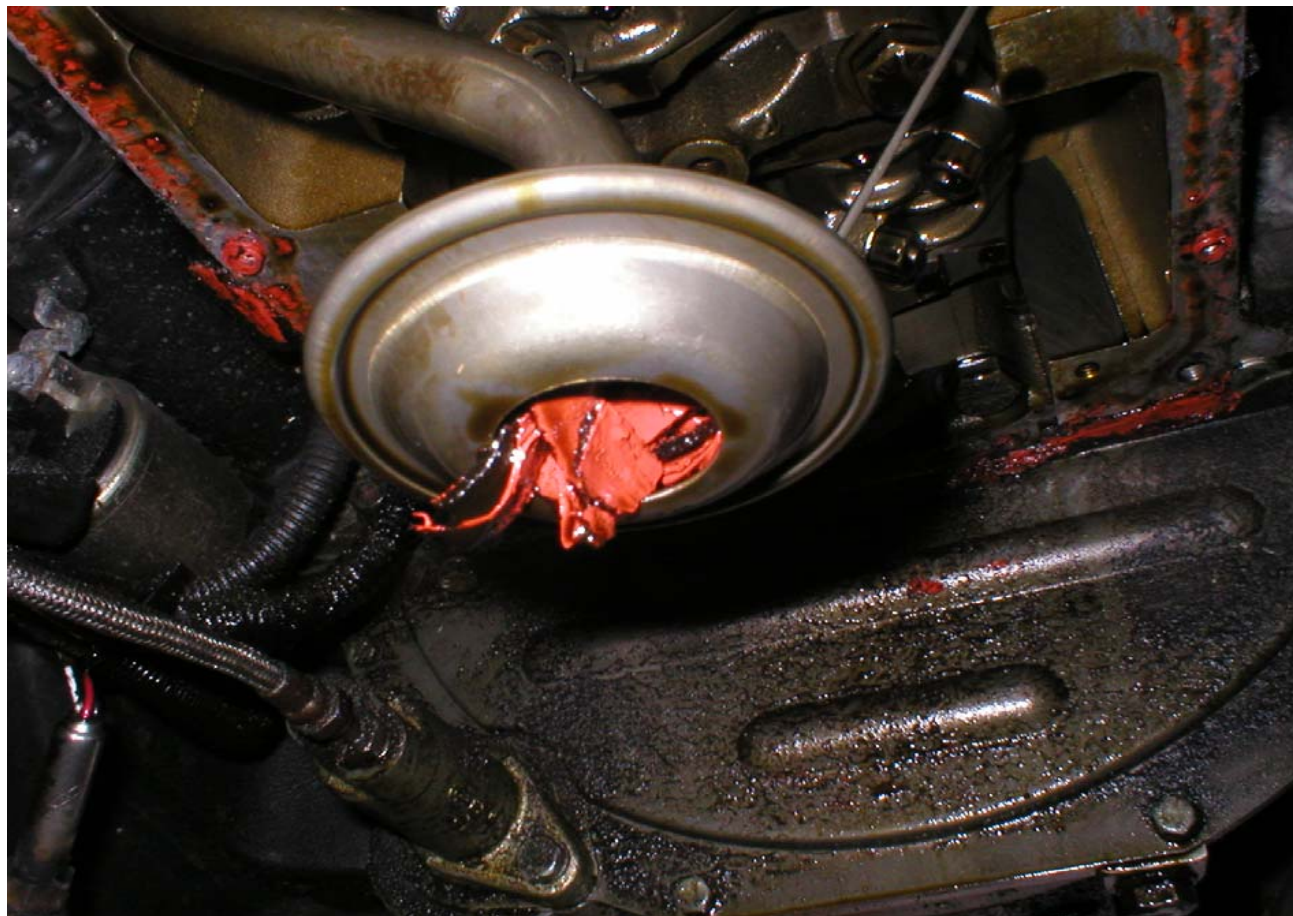
of the engine oil by trying to circulate through the oil passageways! Ugh what a sight – the photo shows the entry to the sump oil strainer where the oil pump sucks up the oil through a metal gauze filter. In this case the filter and orifice were jammed with the orange sealant goo and there was a grave risk there would be oil starvation to the engine because of the blockage!”

On removing the sump Steve found that on a previous occasion someone had attempted to reseal the sump using a sealant but to say they had used it liberally was an understatement! Even used moderately you find it is inevitable that some of the sealant squeezes out as you tighten up the sump – some is visible on the outside but a similar amount extrudes on the inside. When really excessive amounts of sealant are used, then a great deal squeezes out and on the inside it drops off into the oil in the sump. In this case the large clumps of sealant had tried to take on the job

Steve says “in fact a sealant was used to seal the sump at the Factory but we have found it is much better to have a **fibre composite sump gasket** with just a smear of grease to hold it in place as you tighten up the sump. If there are any signs of uneven mating of the surfaces then you can use a smear of silicone sealer, but do use it sparingly.”

Clive Wheatley mentioned there are also cork and rubber sump gaskets but the cork gasket can get brittle over time and the rubber one can soften over time with the heating and cooling cycling. He added “if the rubber gasket is tightened too much, then it can spread which can lead to an oil leak.”
